RSNA Press Release

Ultrasound Pinpoints Vascular Complications from Cosmetic Fillers

Released: December 3, 2025

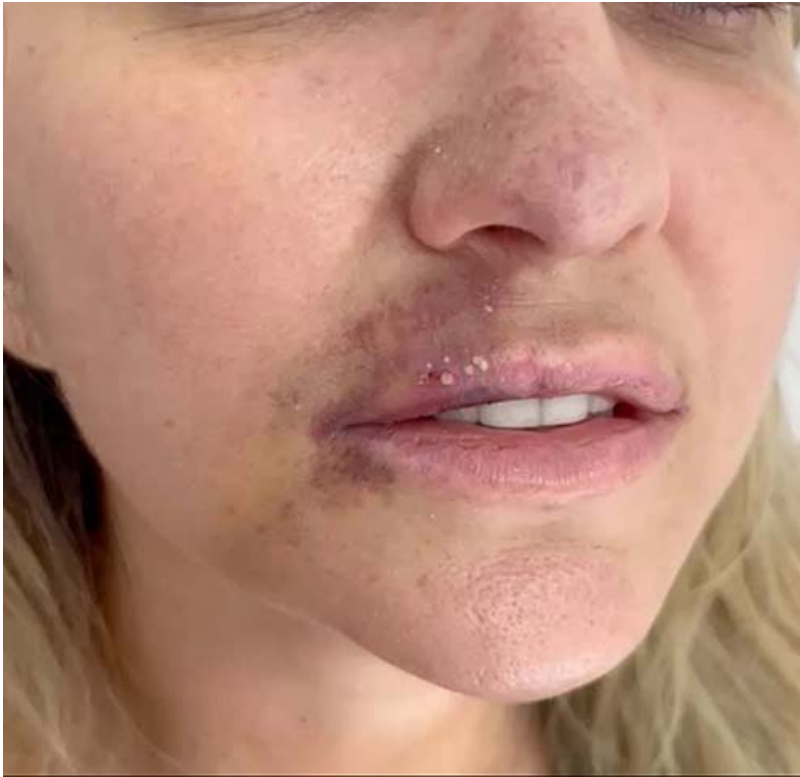
Figure 1. A serious complication from hyaluronic acid fillers is vascular occlusion—the disruption of blood flow in arteries—resulting from misplacement of filler material. If not promptly treated, vascular occlusions can cause necrosis and facial deformity.
