## Ultrasound Pinpoints Vascular Complications from Cosmetic Fillers

Released: December 3, 2025

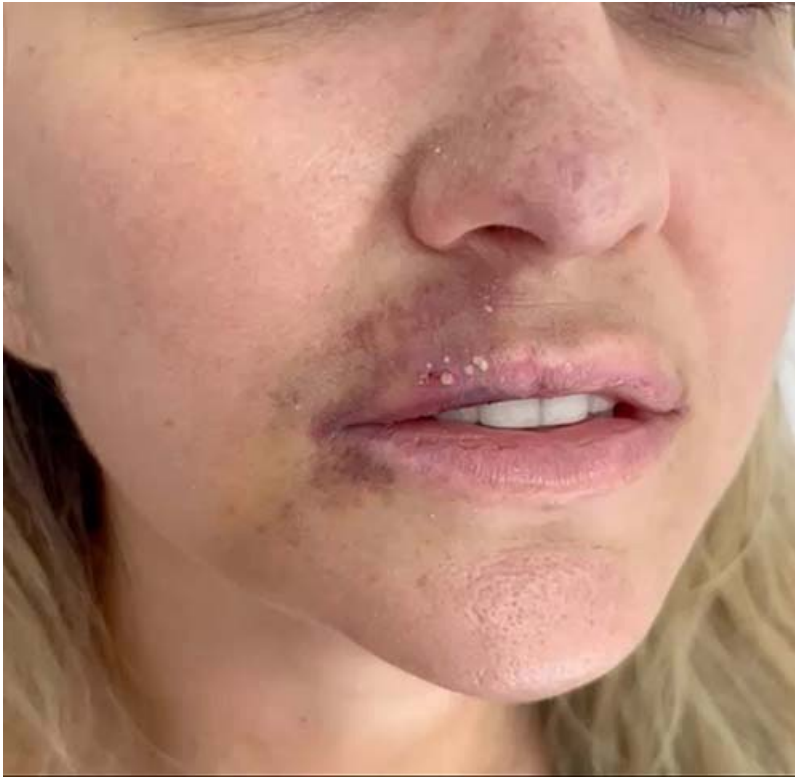
**Figure 1.** A serious complication from hyaluronic acid fillers is vascular occlusion—the disruption of blood flow in arteries—resulting from misplacement of filler material. If not promptly treated, vascular occlusions can cause necrosis and facial deformity.

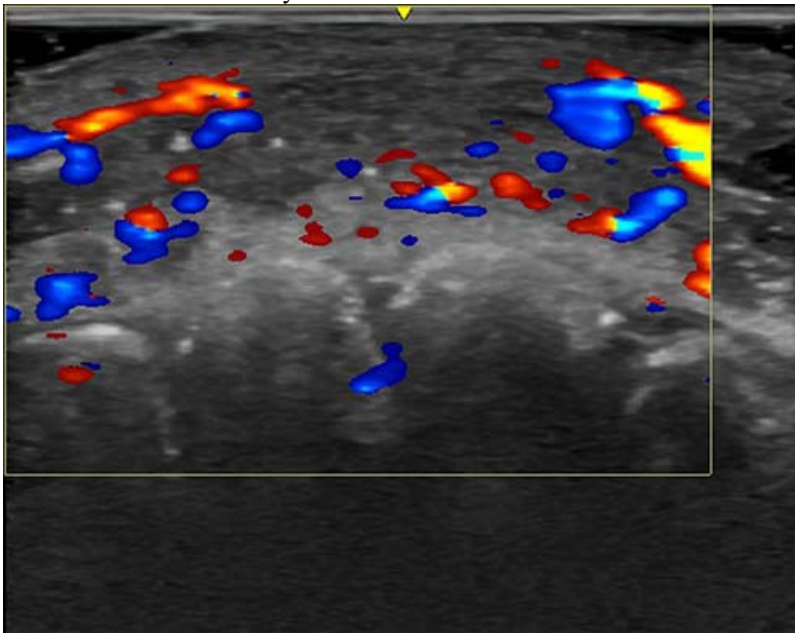
**Figure 2.** Vascular occlusion—the disruption of blood flow in arteries—on ultrasound from hyaluronic acid fillers. This ultrasound image shows absent blood flow in a segment of an artery of the lip.

The most common finding—in 42% of cases—was absent flow to perforator vessels, which connect superficial to deep arteries in the face. In 35% of cases, flow was absent in major blood vessels, and this finding was significantly associated with lateral nasal artery involvement.
