RSNA Press Release

CT Scanner Captures Entire Woolly Mammoth Tusk

Released: August 9, 2022

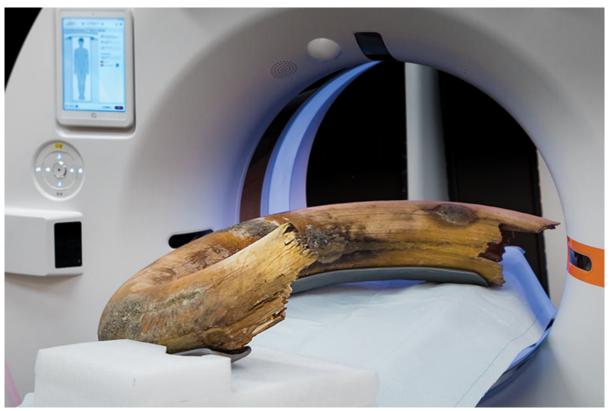
Figure 1. Photograph of the positioning of the woolly mammoth tusk in the scanner. The tusk was fixed in a fiberglass frame to guarantee transport and table-movement stability. There was 1 cm of clearance within the gantry bore.

Newer CT scanners have larger gantries, which is the ring or cylinder into which a patient, or in this case the tusk, is placed. The introduction of larger gantries now allows the opportunity for scanning larger objects that was not possible before, Dr. Niemann noted.

The tusk that the researchers examined was found in central Switzerland and excavated by the heritage and archaeology office of Canton Zug. The tusk is a total of 206 centimeters (cm) in length—nearly 7 feet. It has a basal (measurement at the base) diameter of 16 cm—just over 6 inches. The total object diameter—taking into account its helical, or spiral, curvature—is 80 cm, or just over 2.5 feet.

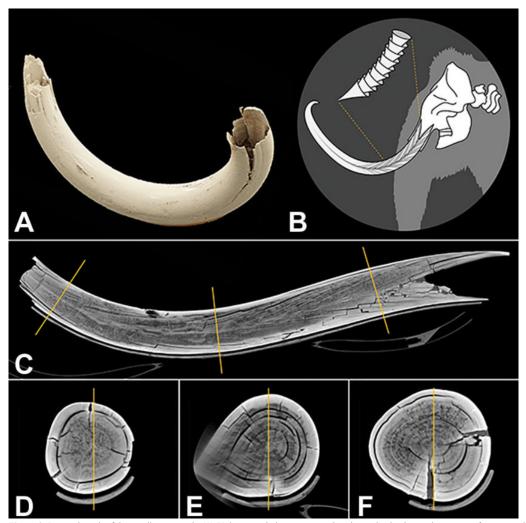
Figure 2. Images in tusk of the woolly mammoth. (A) Volume-rendering reconstruction shows the dentin conal structure of a mammoth tusk for age determination. (B) Illustration of the dentin conal structure of a mammoth tusk. (C) Curved-planar reconstruction CT image centered in the tusk, with orange lines representing the level of perpendicular sections corresponding to images D–F. (D–F) Cross sections of CT images show concentric fissures in the dentin, with (E) mild artifact in the most peripheral scan field.

Tusks mostly consist of two types of material: cementum, a bonelike substance, and dentin, which lies beneath the cementum and accounts for the majority of the tusk's mass. Mammoth tusks are internally structured by annual increments of dentin apposition which, when viewed in longitudinal section (as opposed to cross-section), resemble cone-shaped cups stacked on top of one another. The first "cone" a mammoth creates forms the tip of the tusk, while the cone at the tusk base is the most recent, generated just prior to the animal's death. The cones in between are formed throughout the mammoth's lifetime.

The researchers found a total of 32 cones, resulting in a minimum age of 32 years at the time of death. Even though the mammoth tusk is well-preserved, it is missing the tip, so the estimate obtained is slightly below the actual age of the animal at the time of death.

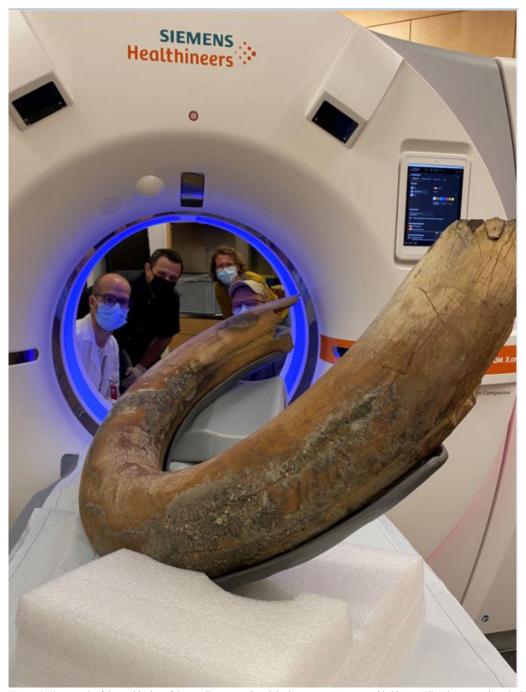
Figure 4. Photograph of the positioning of the woolly mammoth tusk in the scanner. Image provided by Dr. Tilo Niemann and used with permission. High-res (TIF) version

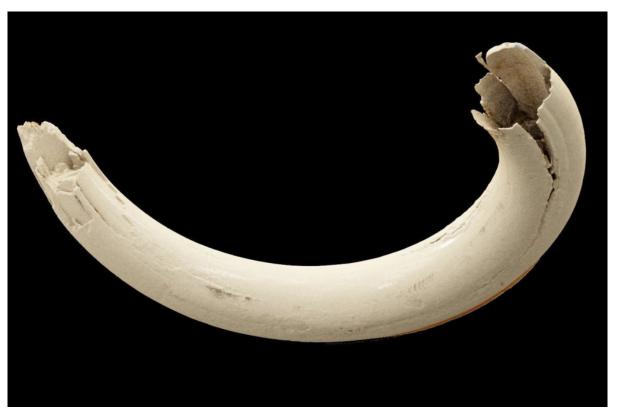
Figure 5. Volume-rendering reconstruction shows the dentin conal structure of a mammoth tusk for age determination. Image provided by Dr. Tilo Niemann and used with permission.

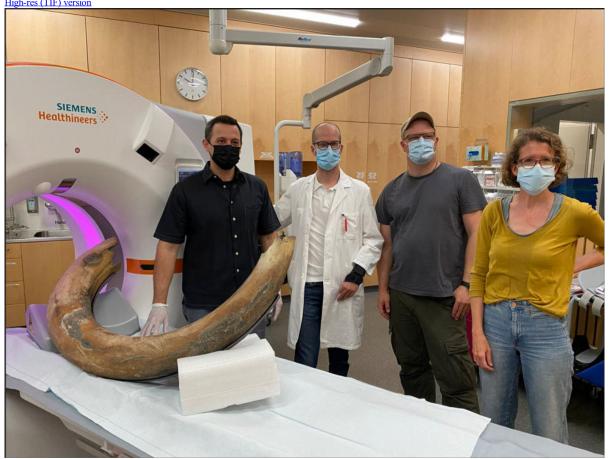
Figure 6. Photograph of the positioning of the woolly mammoth tusk in the scanner. Image provided by Dr. Tilo Niemann and used with permission. High-res (TIF) version

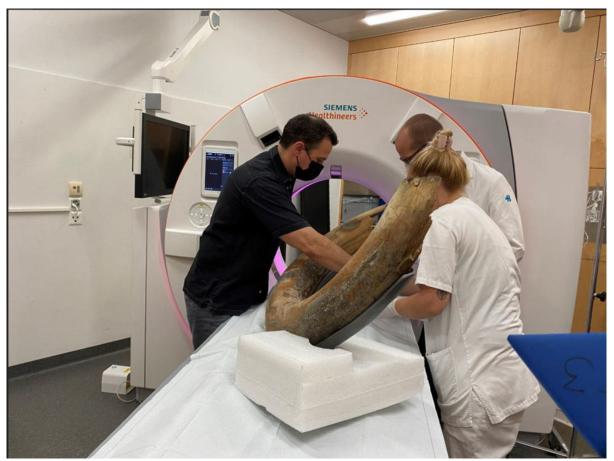
Figure 7. Photograph of the positioning of the woolly mammoth tusk in the scanner. Image provided by Dr. Tilo Niemann and used with permission. High-res (TIF) version

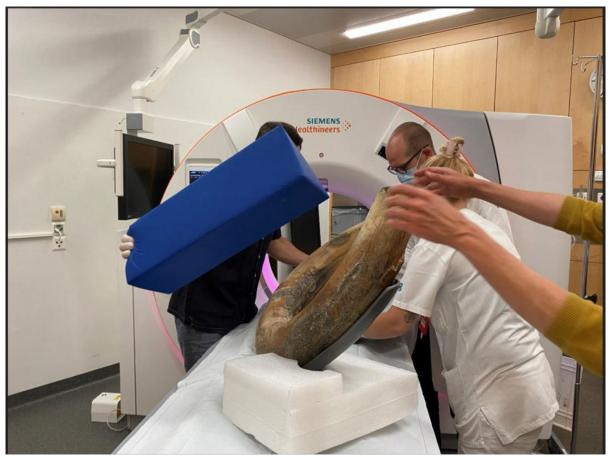
Figure 8. Photograph of the positioning of the woolly mammoth tusk in the scanner. Image provided by Dr. Tilo Niemann and used with permission. High-res (TIF) version

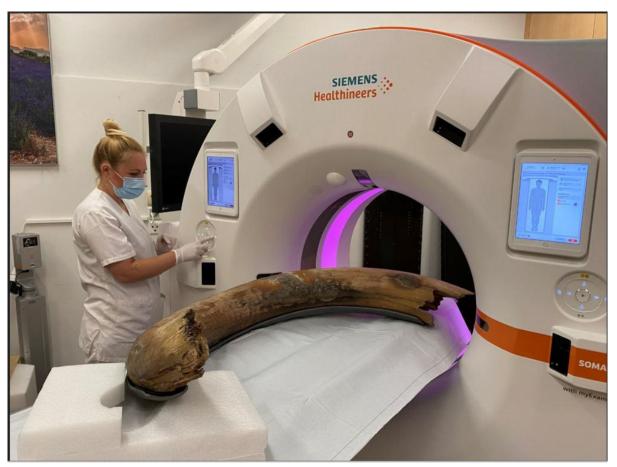
Figure 9. Photograph of the positioning of the woolly mammoth tusk in the scanner. Image provided by Dr. Tilo Niemann and used with permission. High-res (TIF) version

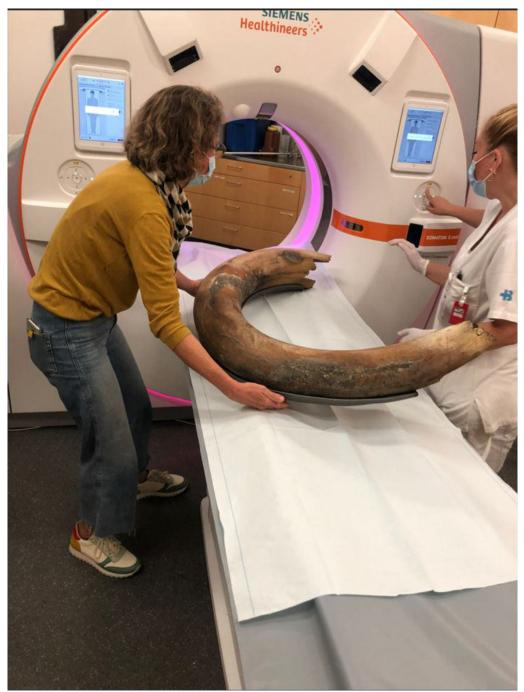
Figure 13. Photograph of the positioning of the woolly mammoth tusk in the scanner. Image provided by Dr. Tilo Niemann and used with permission. High-res (TIF) version

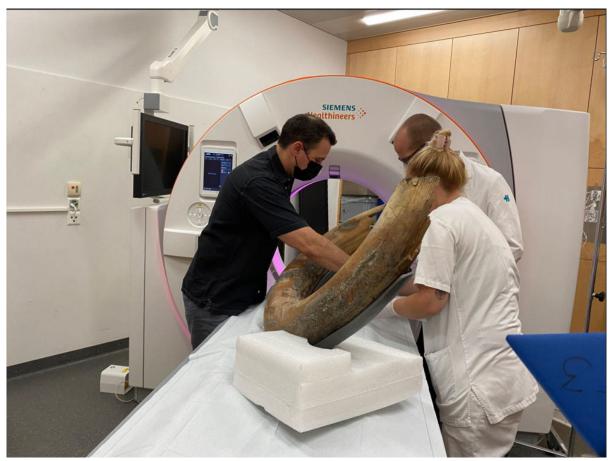
Figure 14. Photograph of the positioning of the woolly mammoth tusk in the scanner. Image provided by Dr. Tilo Niemann and used with permission. High-res (TIF) version
