CT Scanner Captures Entire Woolly Mammoth Tusk

Released: August 9, 2022

- For the first time, researchers successfully captured CT images of an entire woolly mammoth tusk.
- With earlier CT scanners, it was not possible to scan a whole tusk *in toto* without the need for fragmentation.
- Using the larger-gantry CT scanner, researchers were able to capture a clear image of the interior of the nearly 7-foot tusk and estimated the minimum age of 32 years at the time of death.

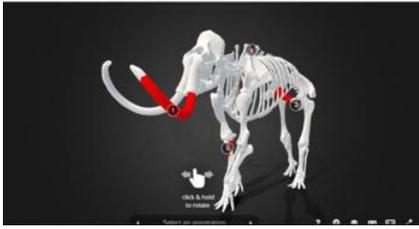
Video 1. 3D animation of the woolly mammoth.

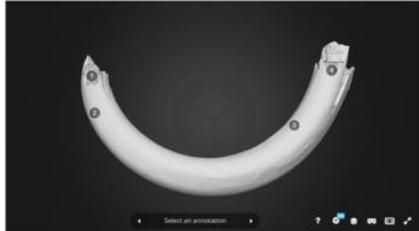
Video 2. 3D animation of mammoth tusk.

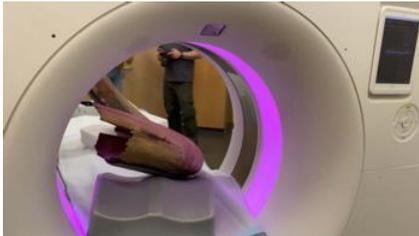
Video 3. The woolly mammoth tusk going through the CT scanner. Video provided by Dr. Tilo Niemann and used with permission.

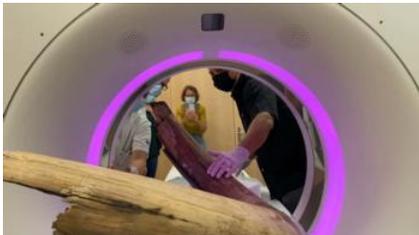
Video 4. The researchers positioning the woolly mammoth tusk in the CT. Video provided by Dr. Tilo Niemann and used with permission.

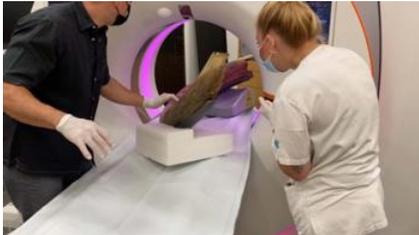
Video 5. The researchers positioning the woolly mammoth tusk in the CT. Video provided by Dr. Tilo Niemann and used with permission.

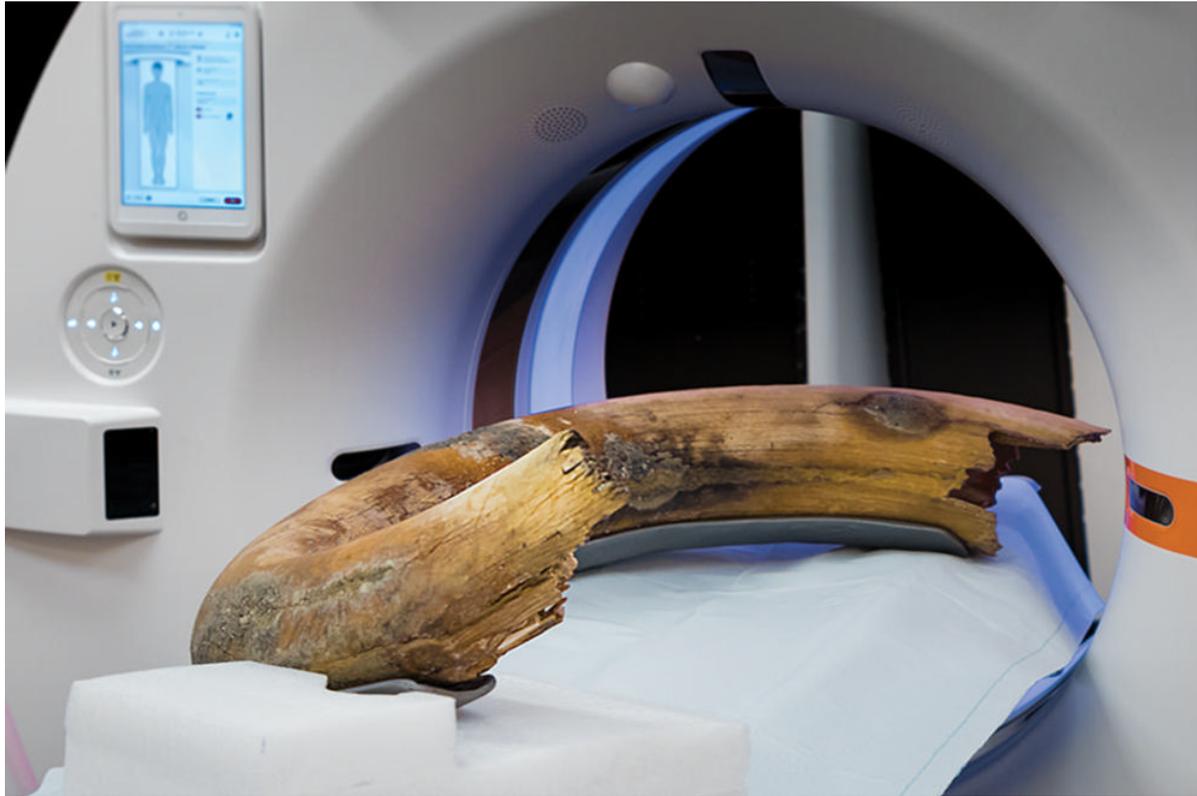
Figure 1. Photograph of the positioning of the woolly mammoth tusk in the scanner. The tusk was fixed in a fiberglass frame to guarantee transport and table-movement stability. There was 1 cm of clearance within the gantry bore.
[High-res. \(TIF\) version](#)

Newer CT scanners have larger gantries, which is the ring or cylinder into which a patient, or in this case the tusk, is placed. The introduction of larger gantries now allows the opportunity for scanning larger objects that was not possible before, Dr. Niemann noted.

Using the larger-gantry CT scanner, researchers, in collaboration with the Institute of Evolutionary Medicine, University of Zurich, were able to capture a clear image of the entire tusk’s interior.

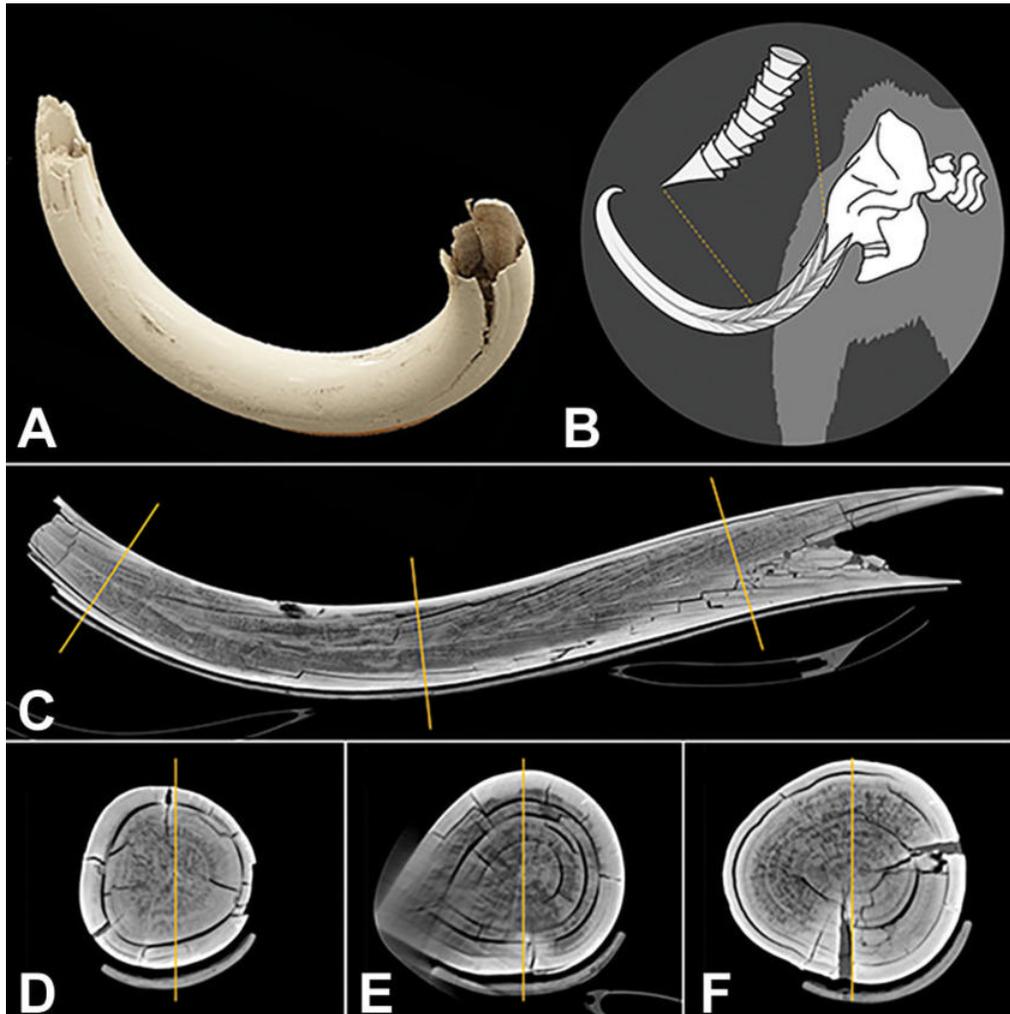
Figure 2. Images in tusk of the woolly mammoth. **(A)** Volume-rendering reconstruction shows the dentin conal structure of a mammoth tusk for age determination. **(B)** Illustration of the dentin conal structure of a mammoth tusk. **(C)** Curved-planar reconstruction CT image centered in the tusk, with orange lines representing the level of perpendicular sections corresponding to images **D–F**. **(D–F)** Cross sections of CT images show concentric fissures in the dentin, with **(E)** mild artifact in the most peripheral scan field.
[High-res \(TIF\) version](#)

Tusks mostly consist of two types of material: cementum, a bonelike substance, and dentin, which lies beneath the cementum and accounts for the majority of the tusk’s mass. Mammoth tusks are internally structured by annual increments of dentin apposition which, when viewed in longitudinal section (as opposed to cross-section), resemble cone-shaped cups stacked on top of one another. The first “cone” a mammoth creates forms the tip of the tusk, while the cone at the tusk base is the most recent, generated just prior to the animal’s death. The cones in between are formed throughout the mammoth’s lifetime.

The researchers found a total of 32 cones, resulting in a minimum age of 32 years at the time of death. Even though the mammoth tusk is well-preserved, it is missing the tip, so the estimate obtained is slightly below the actual age of the animal at the time of death.

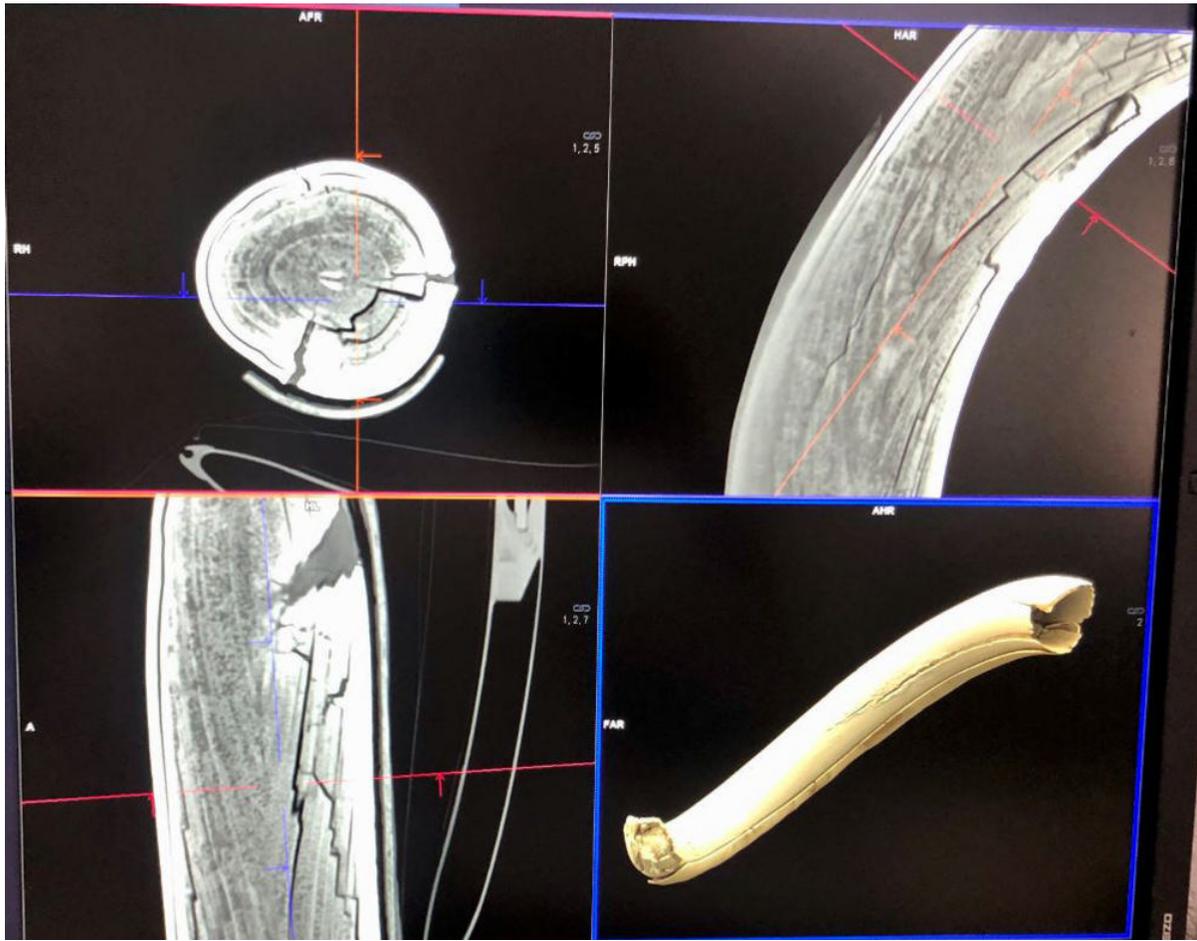
Figure 3. Images in tusk of the woolly mammoth. Image provided by Dr. Tilo Niemann and used with permission.
[High-res \(TIF\) version](#)

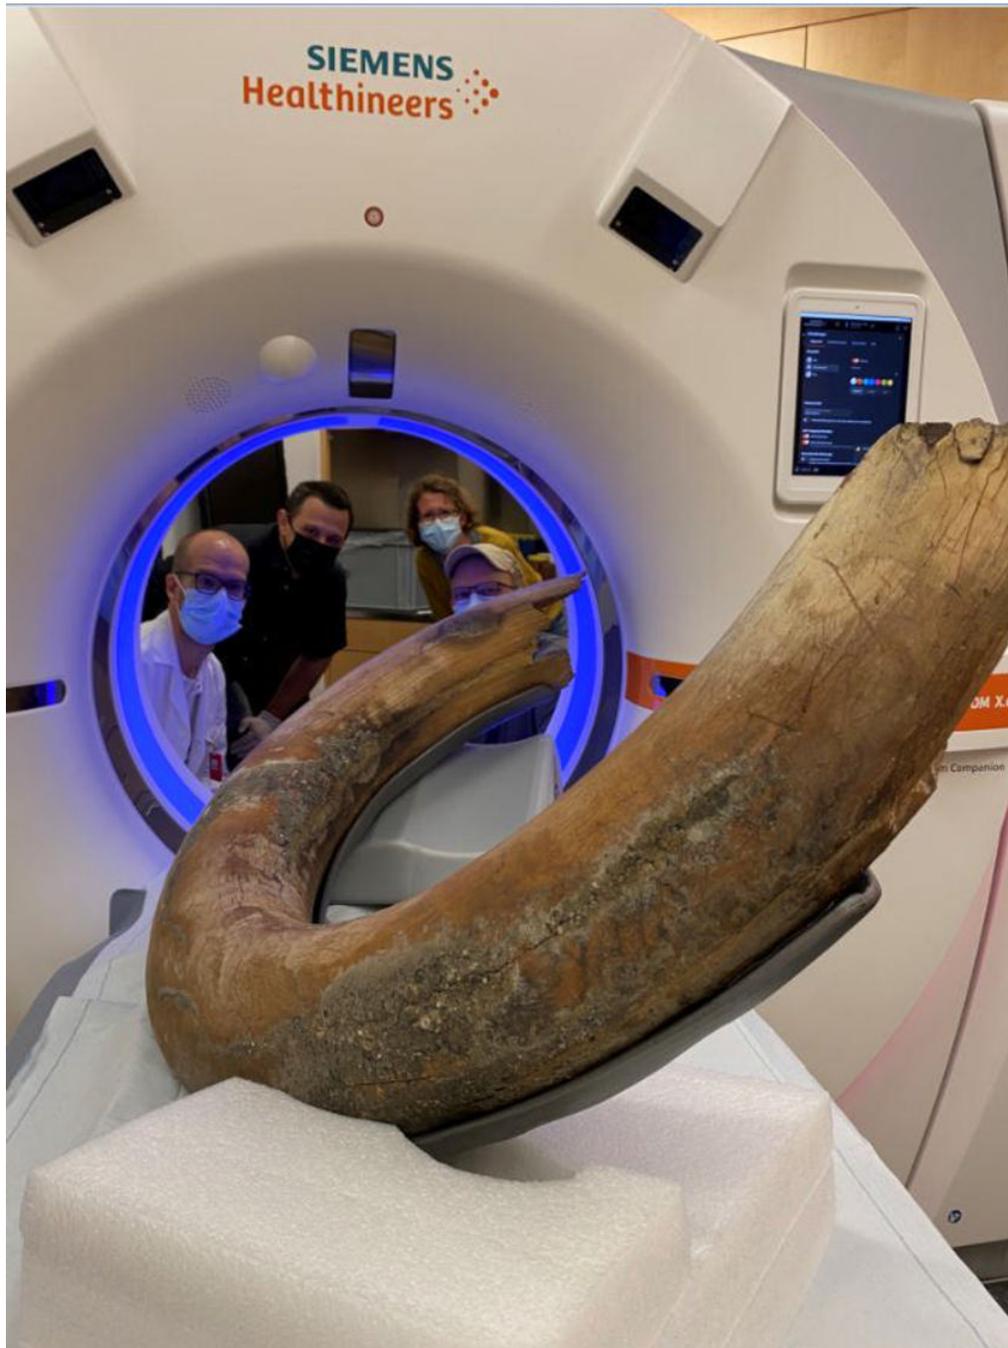
Figure 4. Photograph of the positioning of the woolly mammoth tusk in the scanner. Image provided by Dr. Tilo Niemann and used with permission.
[High-res \(TIF\) version](#)

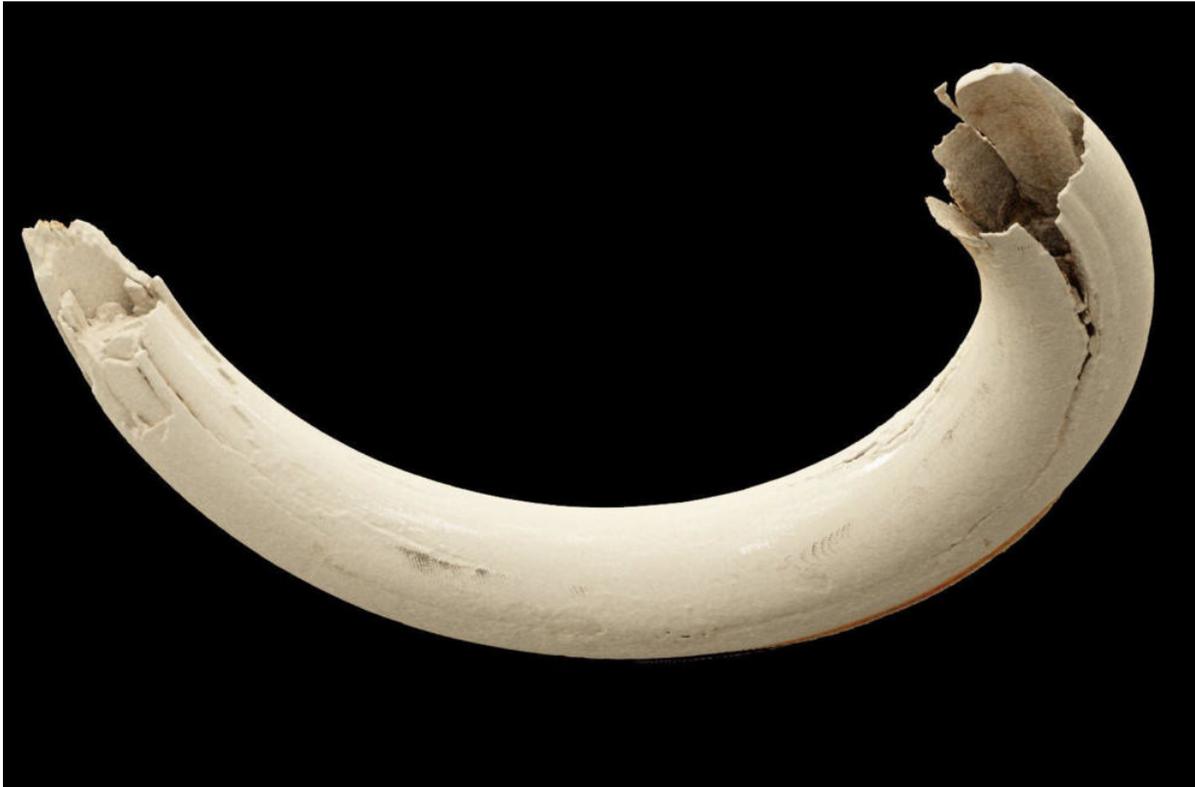
Figure 5. Volume-rendering reconstruction shows the dentin conal structure of a mammoth tusk for age determination. Image provided by Dr. Tilo Niemann and used with permission.
[High-res \(TIF\) version](#)

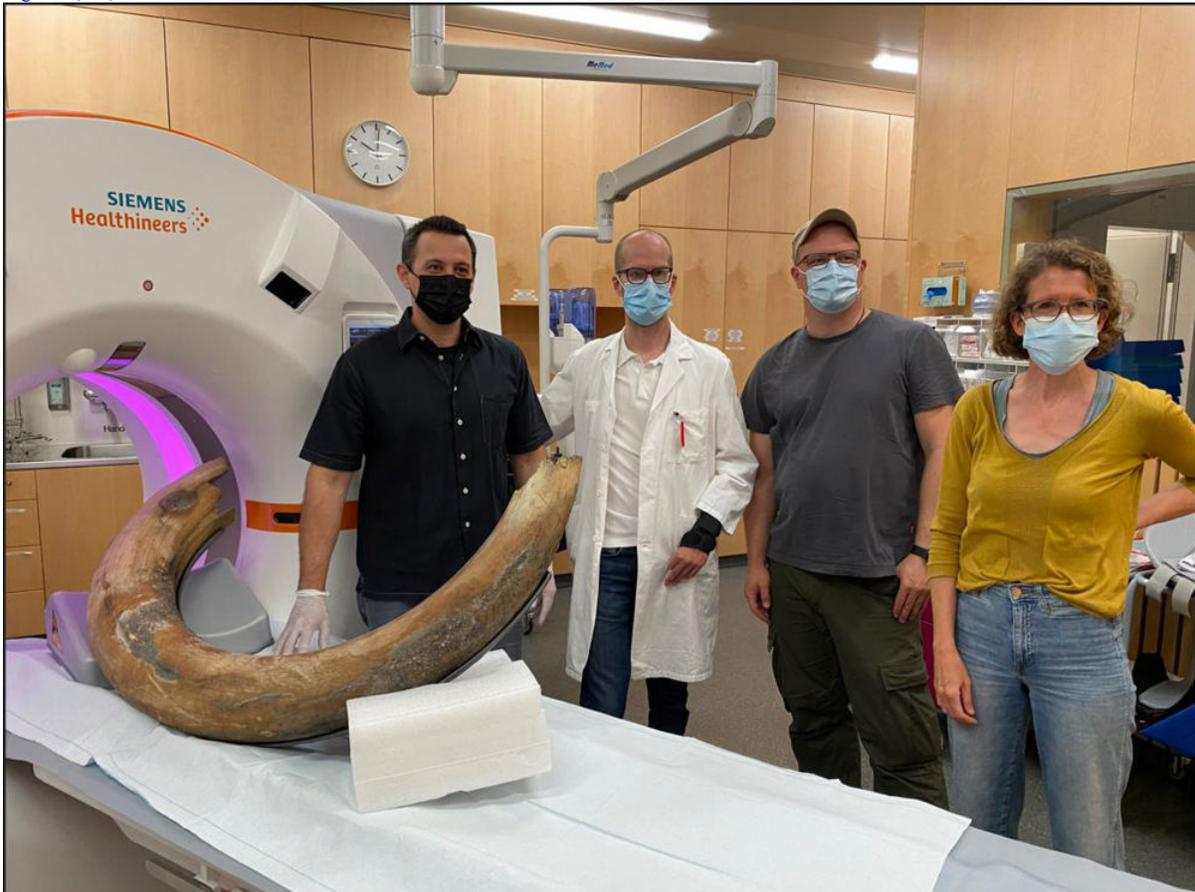
Figure 6. Photograph of the positioning of the woolly mammoth tusk in the scanner. Image provided by Dr. Tilo Niemann and used with permission.
[High-res \(TIF\) version](#)

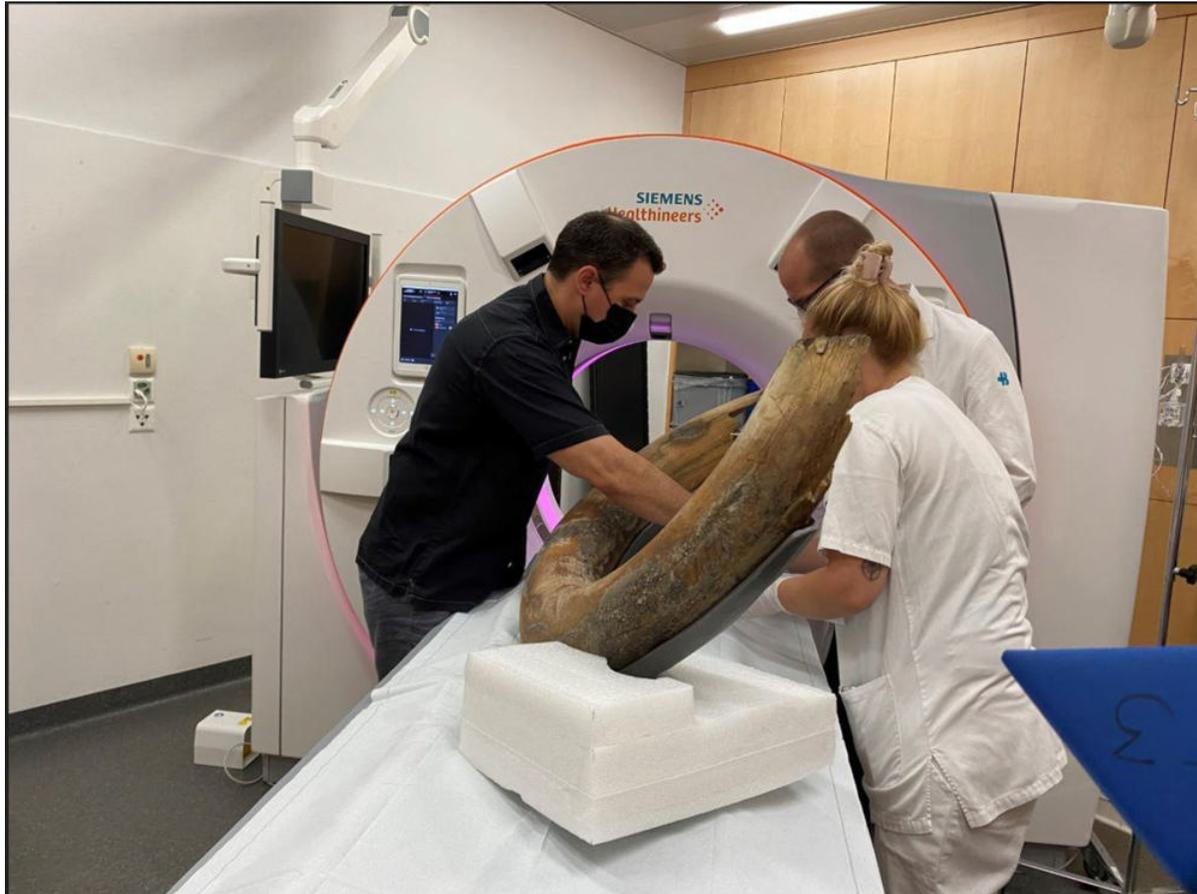
Figure 7. Photograph of the positioning of the woolly mammoth tusk in the scanner. Image provided by Dr. Tilo Niemann and used with permission.
[High-res \(TIF\) version](#)

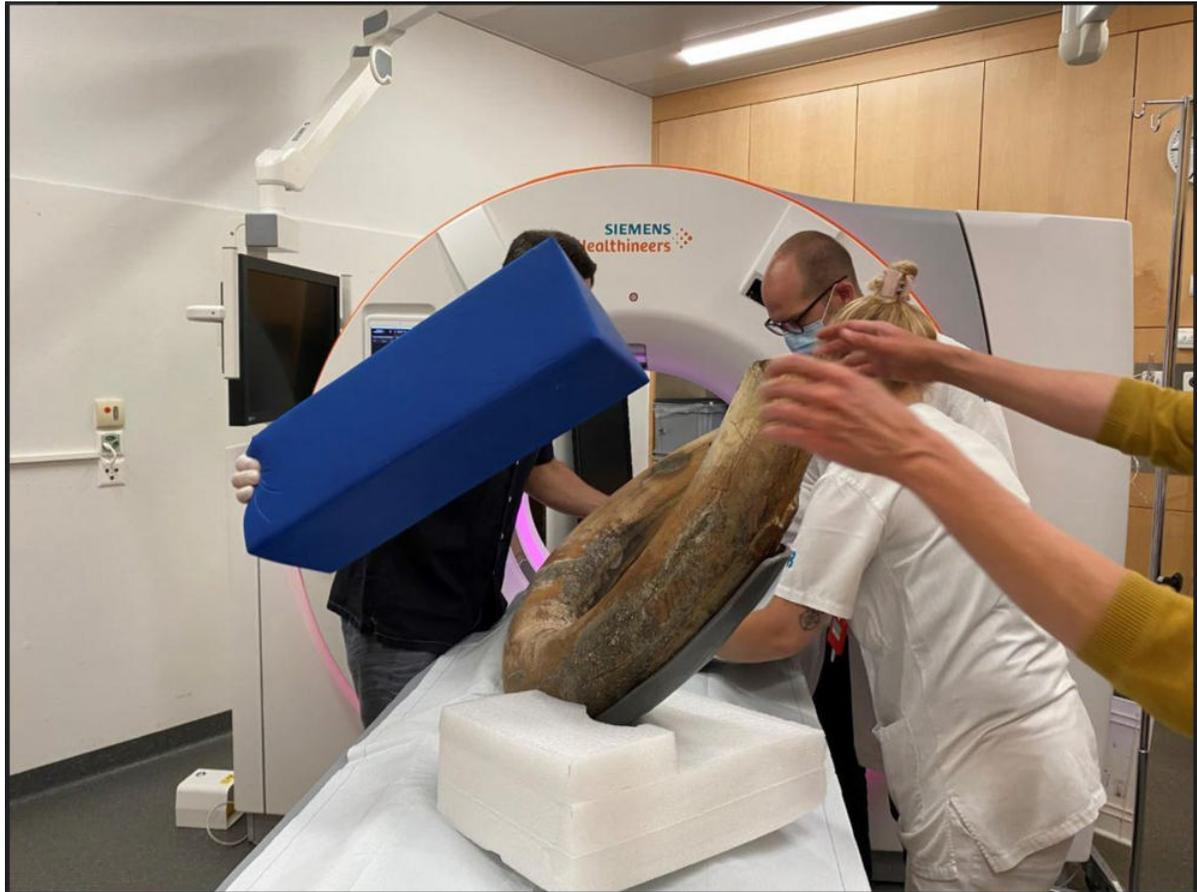
Figure 8. Photograph of the positioning of the woolly mammoth tusk in the scanner. Image provided by Dr. Tilo Niemann and used with permission.
[High-res \(TIFF\) version](#)

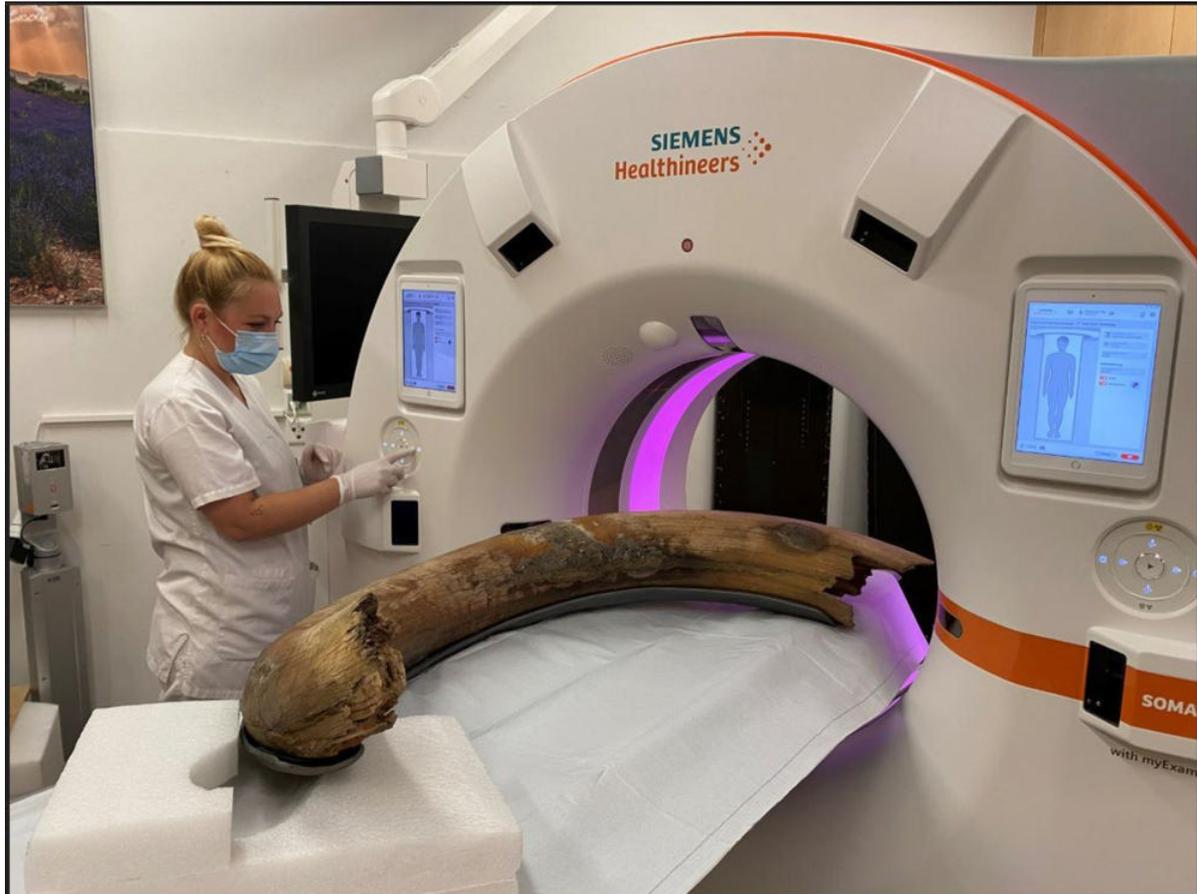
Figure 9. Photograph of the positioning of the woolly mammoth tusk in the scanner. Image provided by Dr. Tilo Niemann and used with permission.
[High-res \(TIF\) version](#)

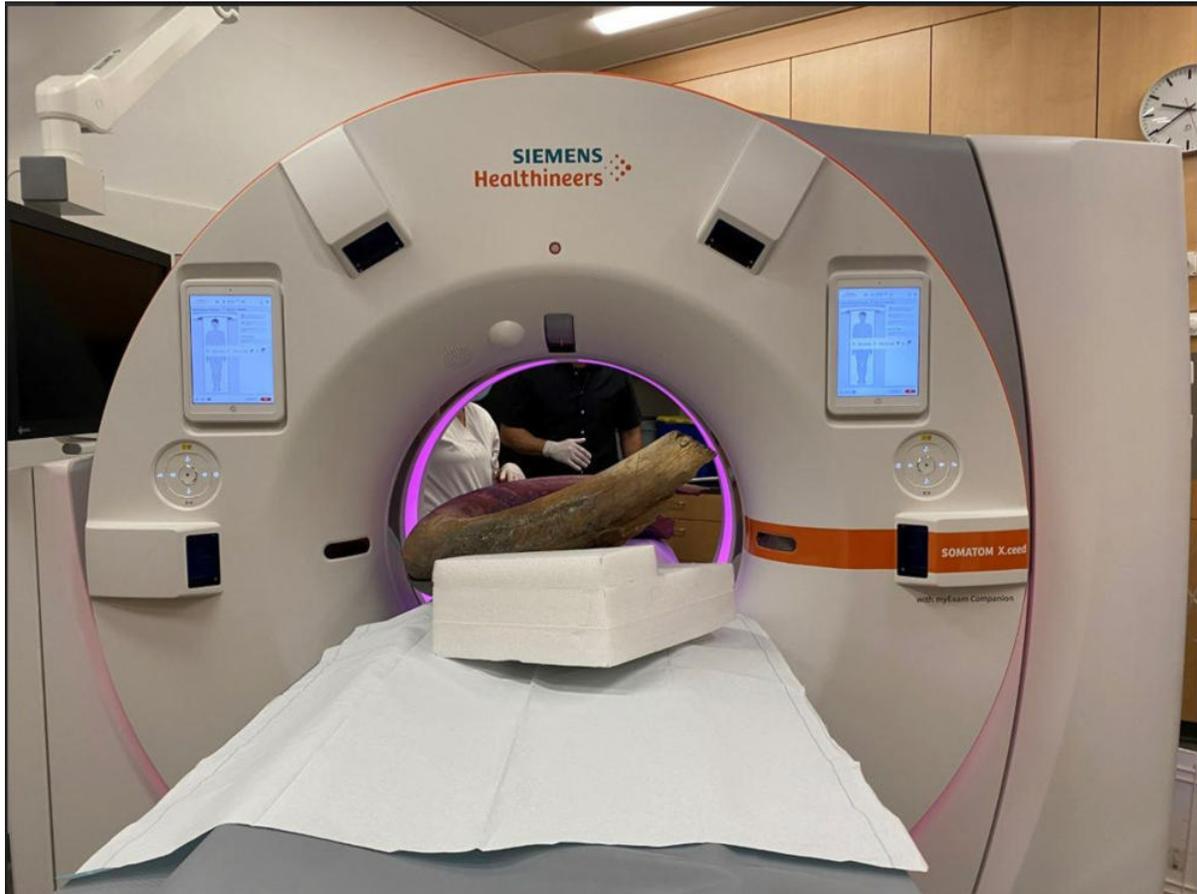
Figure 10. Photograph of the woolly mammoth tusk in the scanner. Image provided by Dr. Tilo Niemann and used with permission.
[High-res \(TIF\) version](#)

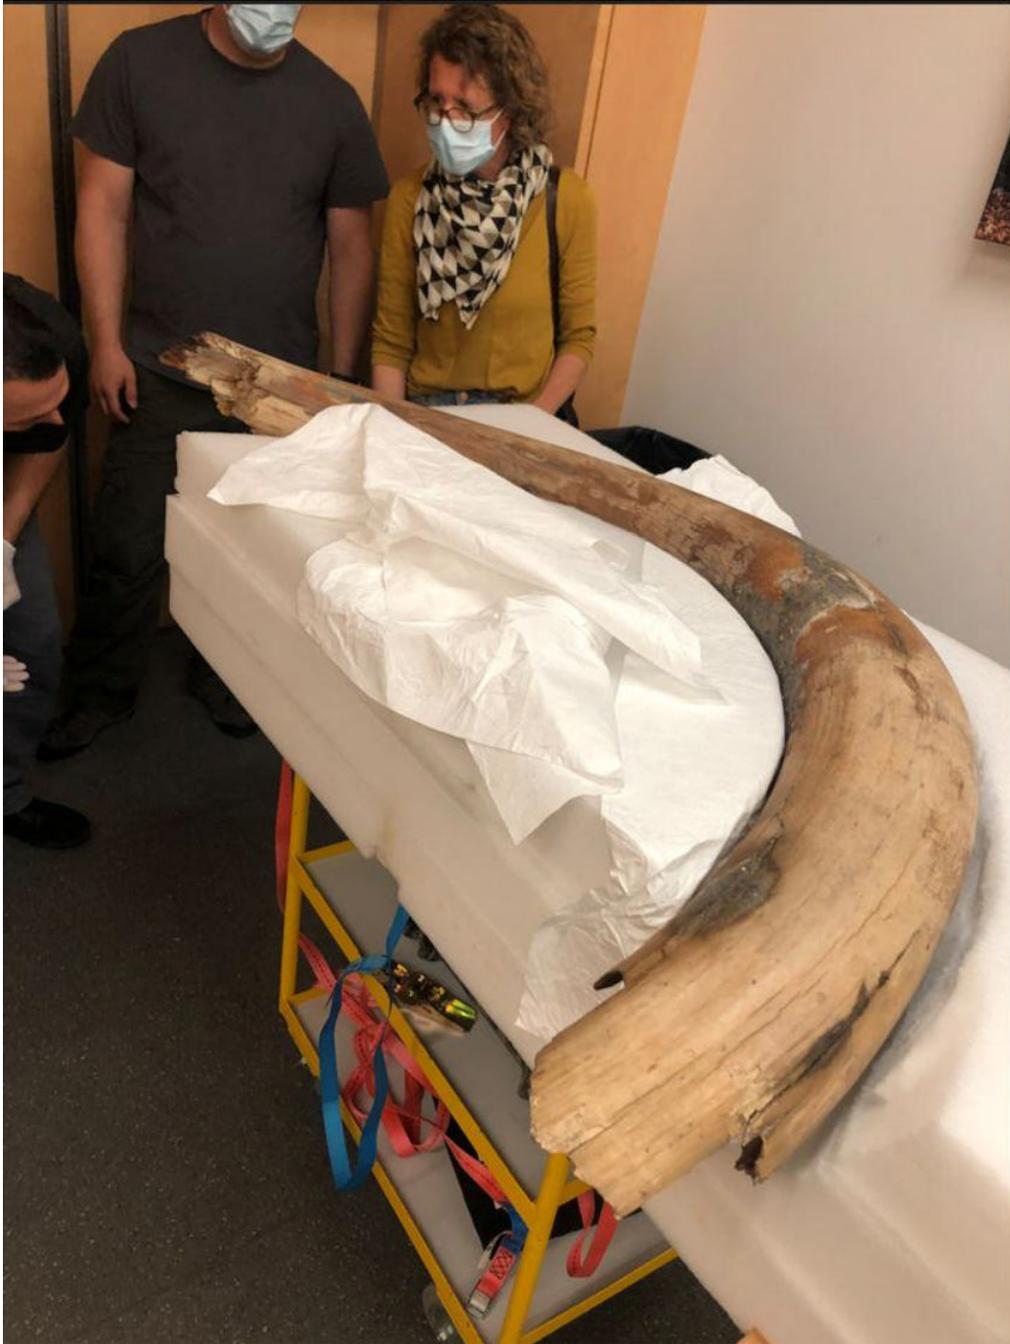
Figure 11. The woolly mammoth tusk. Image provided by Dr. Tilo Niemann and used with permission.
[High-res \(TIF\) version](#)

The tusk that the researchers examined was found in central Switzerland and excavated by the heritage and archaeology office of Canton Zug. The tusk is a total of 206 centimeters (cm) in length—nearly 7 feet. It has a basal (measurement at the base) diameter of 16 cm—just over 6 inches. The total object diameter—taking into account its helical, or spiral, curvature—is 80 cm, or just over 2.5 feet.

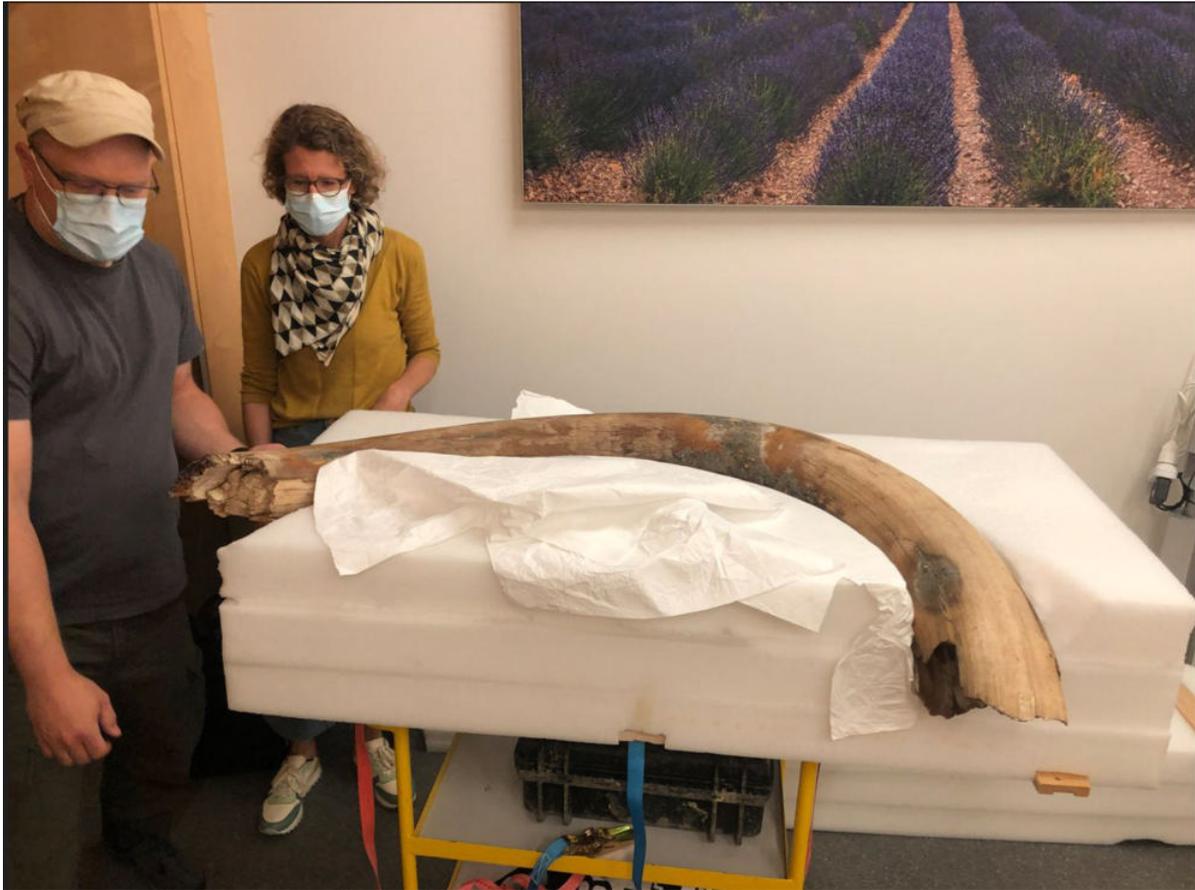
Figure 12. The woolly mammoth tusk. Image provided by Dr. Tilo Niemann and used with permission.
[High-res. \(TIFF\) version](#)

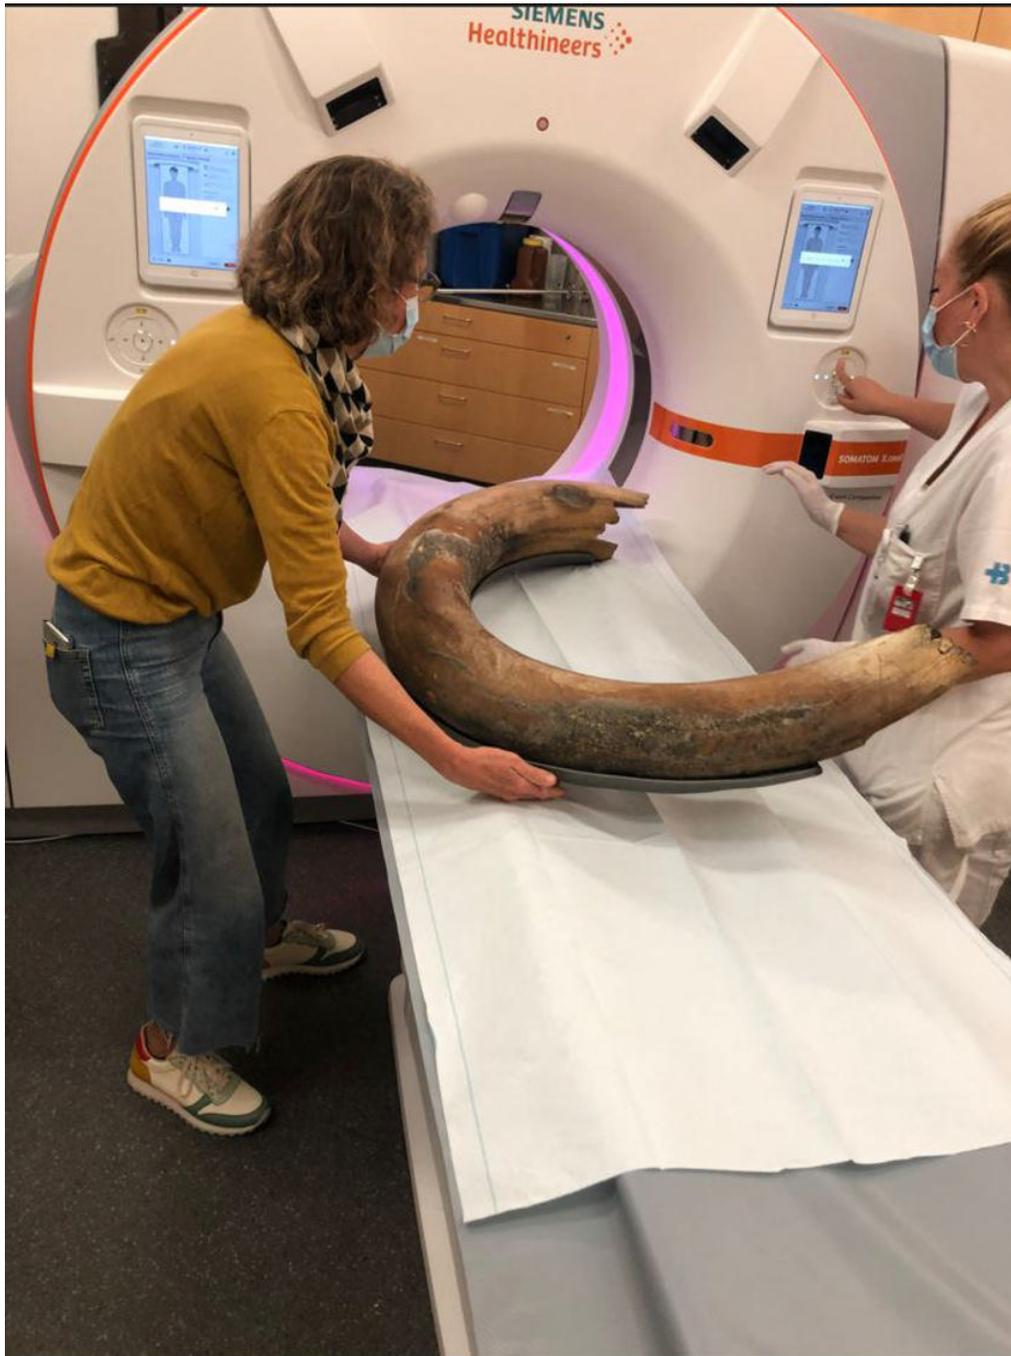
Figure 13. Photograph of the positioning of the woolly mammoth tusk in the scanner. Image provided by Dr. Tilo Niemann and used with permission.
[High-res \(TIF\) version](#)

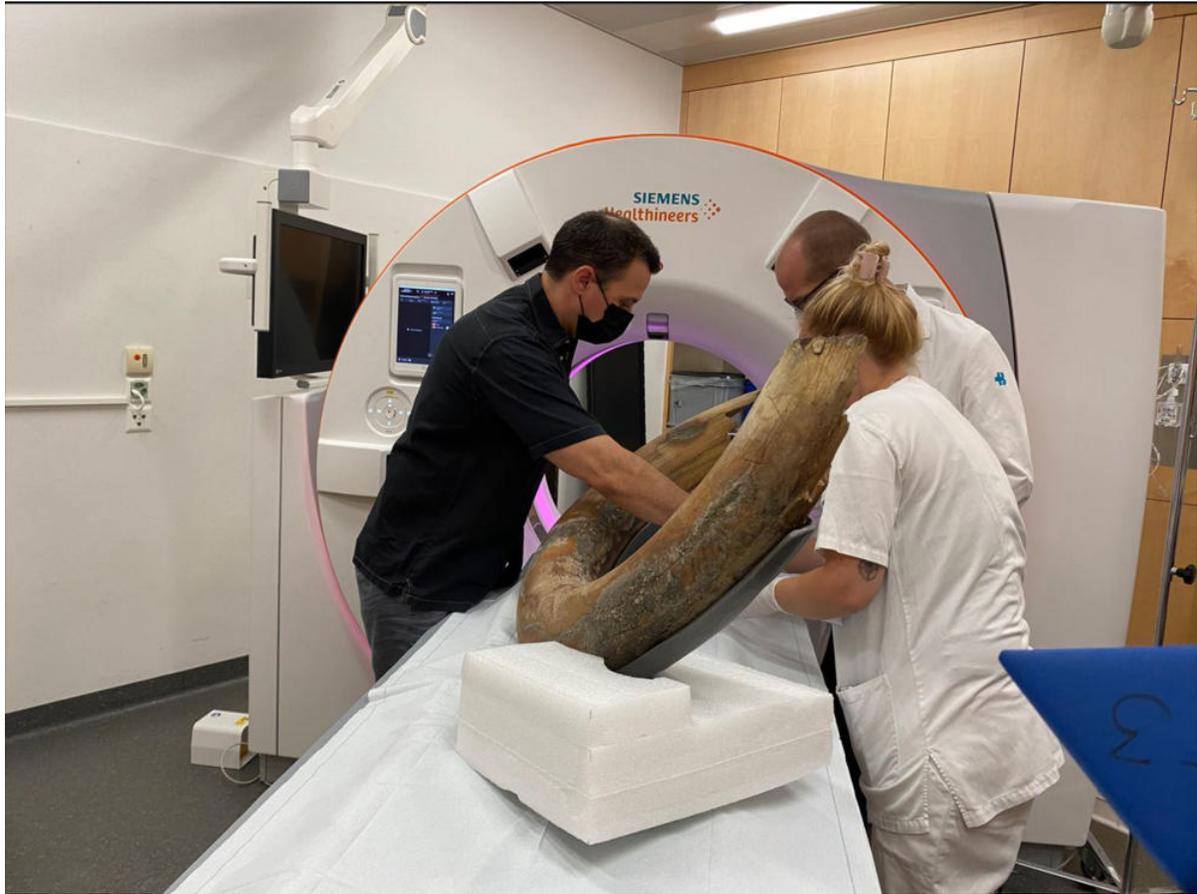
Figure 14. Photograph of the positioning of the woolly mammoth tusk in the scanner. Image provided by Dr. Tilo Niemann and used with permission.
[High-res \(TIF\) version](#)

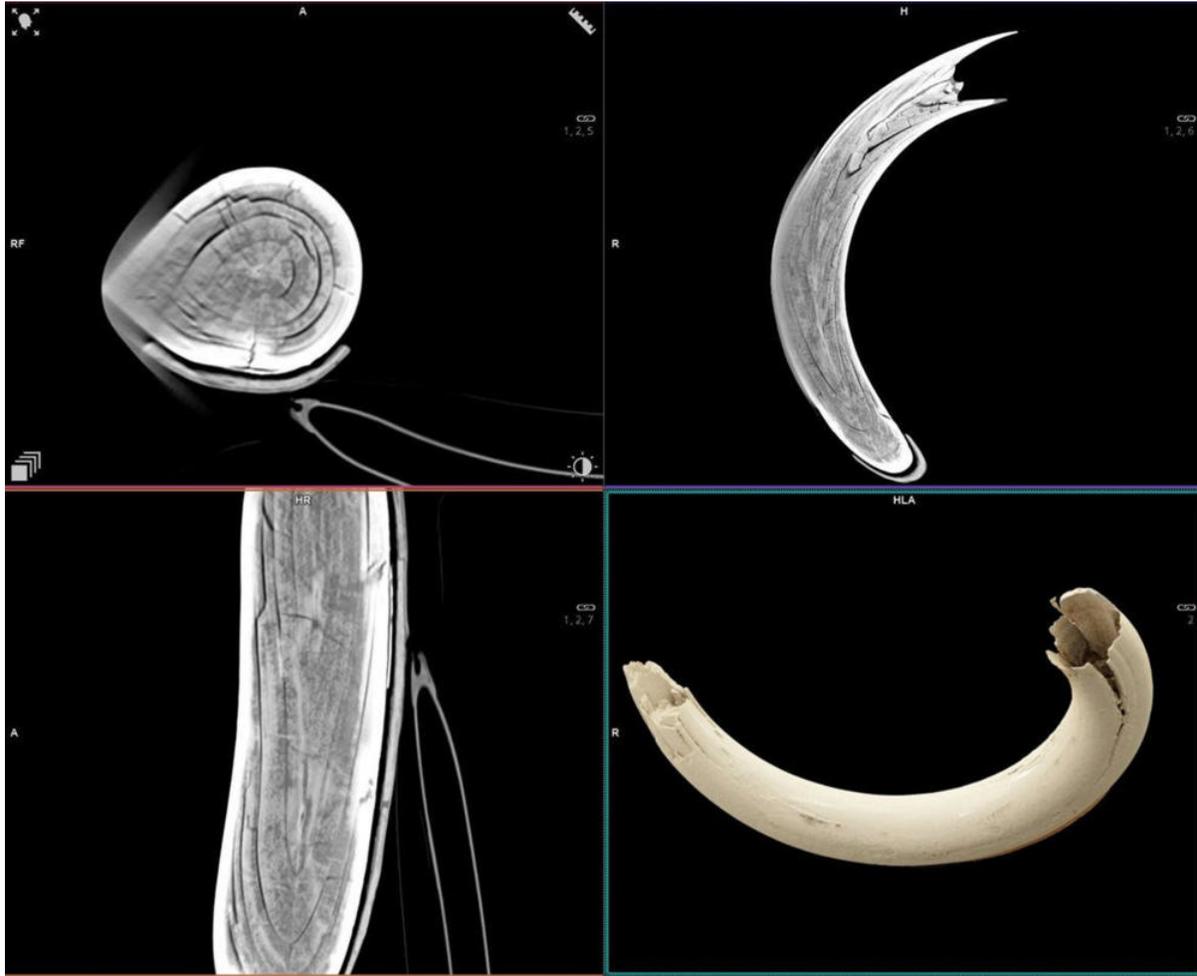
Figure 15. Images in tusk of the woolly mammoth. Image provided by Dr. Tilo Niemann and used with permission.
[High-res. \(TIF\) version](#)
