Ultrasound Reveals Knuckle-Cracking Fireworks

Released: December 1, 2015

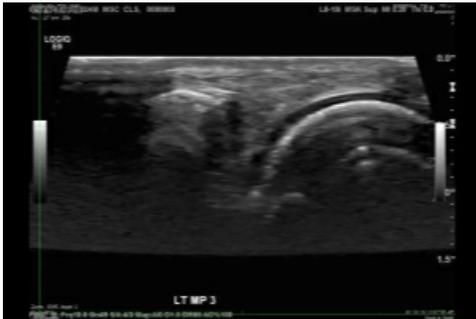
Video 1. Video showing knuckle joint during cracking.

"What we saw was a bright flash on ultrasound, like a firework exploding in the joint," Dr. Boutin said. "It was quite an unexpected finding."

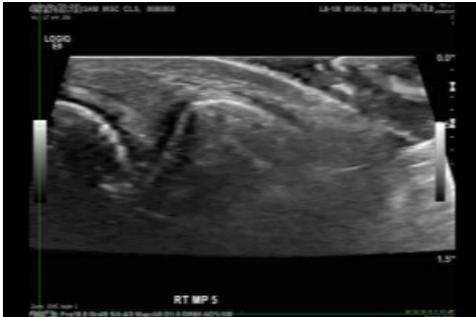
Video 2. Video showing knuckle joint during cracking.

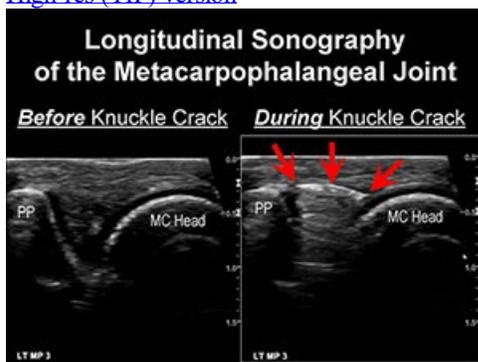
Figure 4. Before and during knuckle cracking.

Using the flashes on the ultrasound images, the radiologists were able to identify the joints with audible cracks with at least 94 percent specificity.
