## High-Strength MRI May Release Mercury from Amalgam Dental Fillings

"Ex Vivo Mercury Release from Dental Amalgam after 7.0-T and 1.5-T MRI."

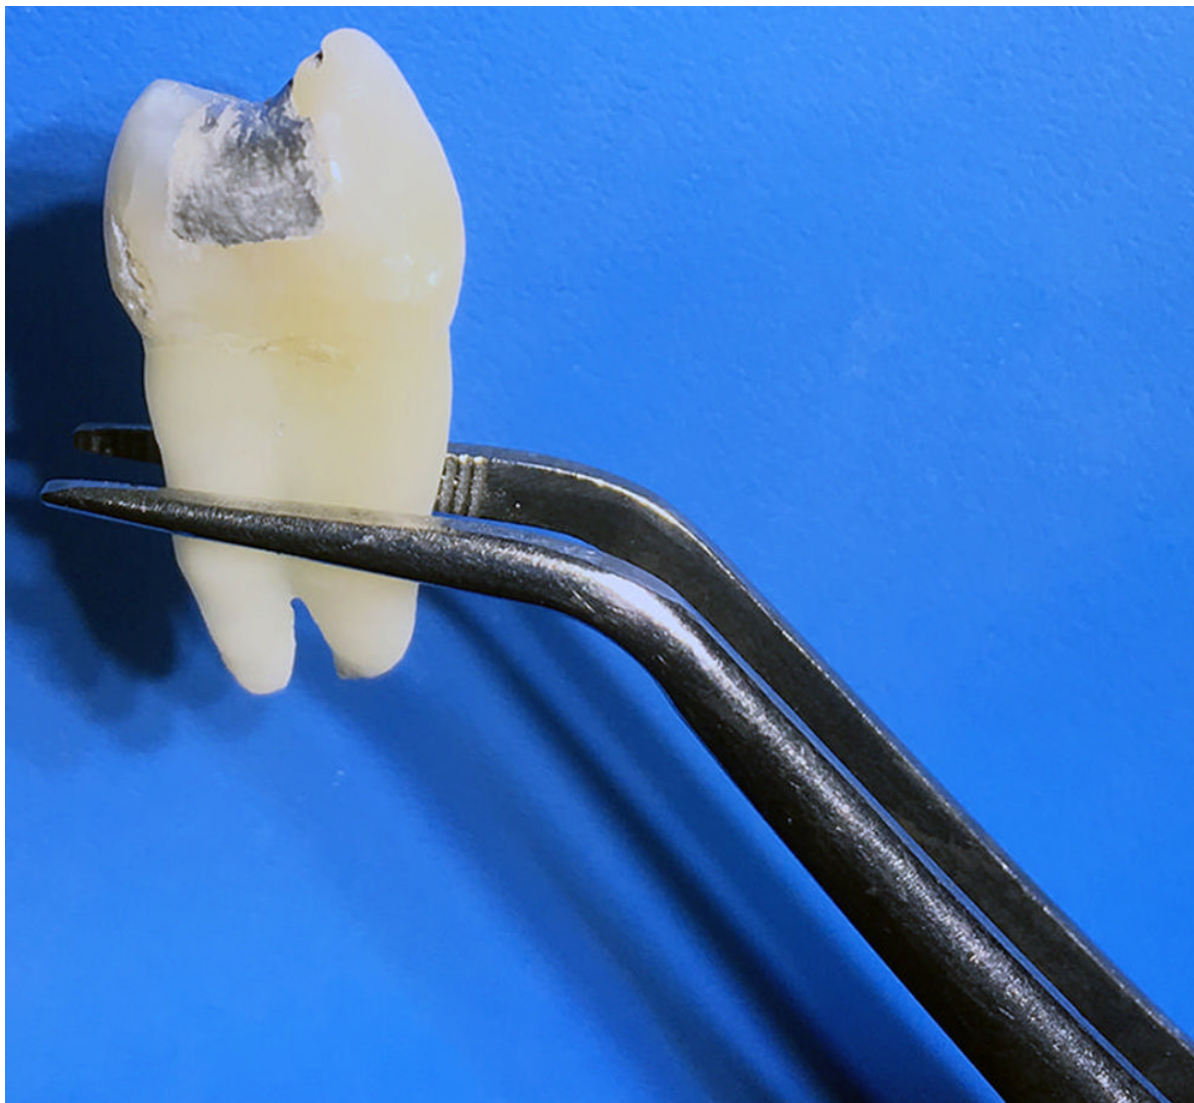
**Figure 1.** Sample tooth with amalgam filling routinely used in clinical practice.

The researchers opened two-sided cavities in each tooth and applied amalgam fillings. After nine days, two groups of 20 randomly selected teeth were placed in a solution of artificial saliva immediately followed by 20 minutes of exposure to 1.5-T or 7-T MRI. A control group of teeth was placed in artificial saliva only.

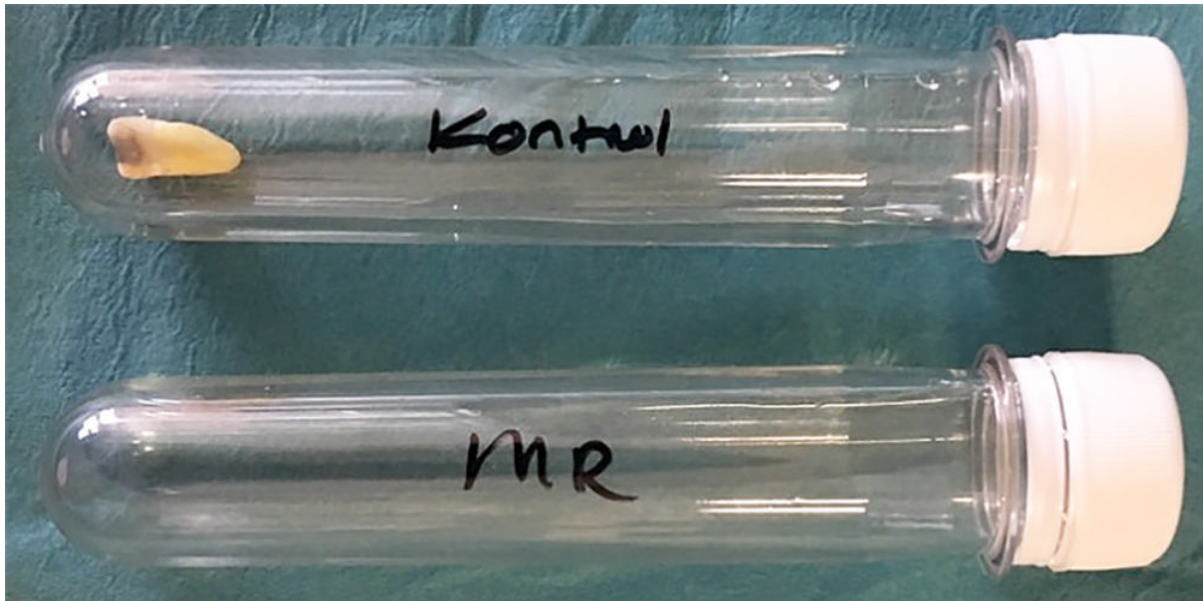
**Figure 2.** Sample tubes containing, top, tooth with dental amalgam in artificial saliva in preparation for testing and, bottom, artificial saliva only. Tube had previously undergone MRI, and the tooth was removed 24 hours after imaging.

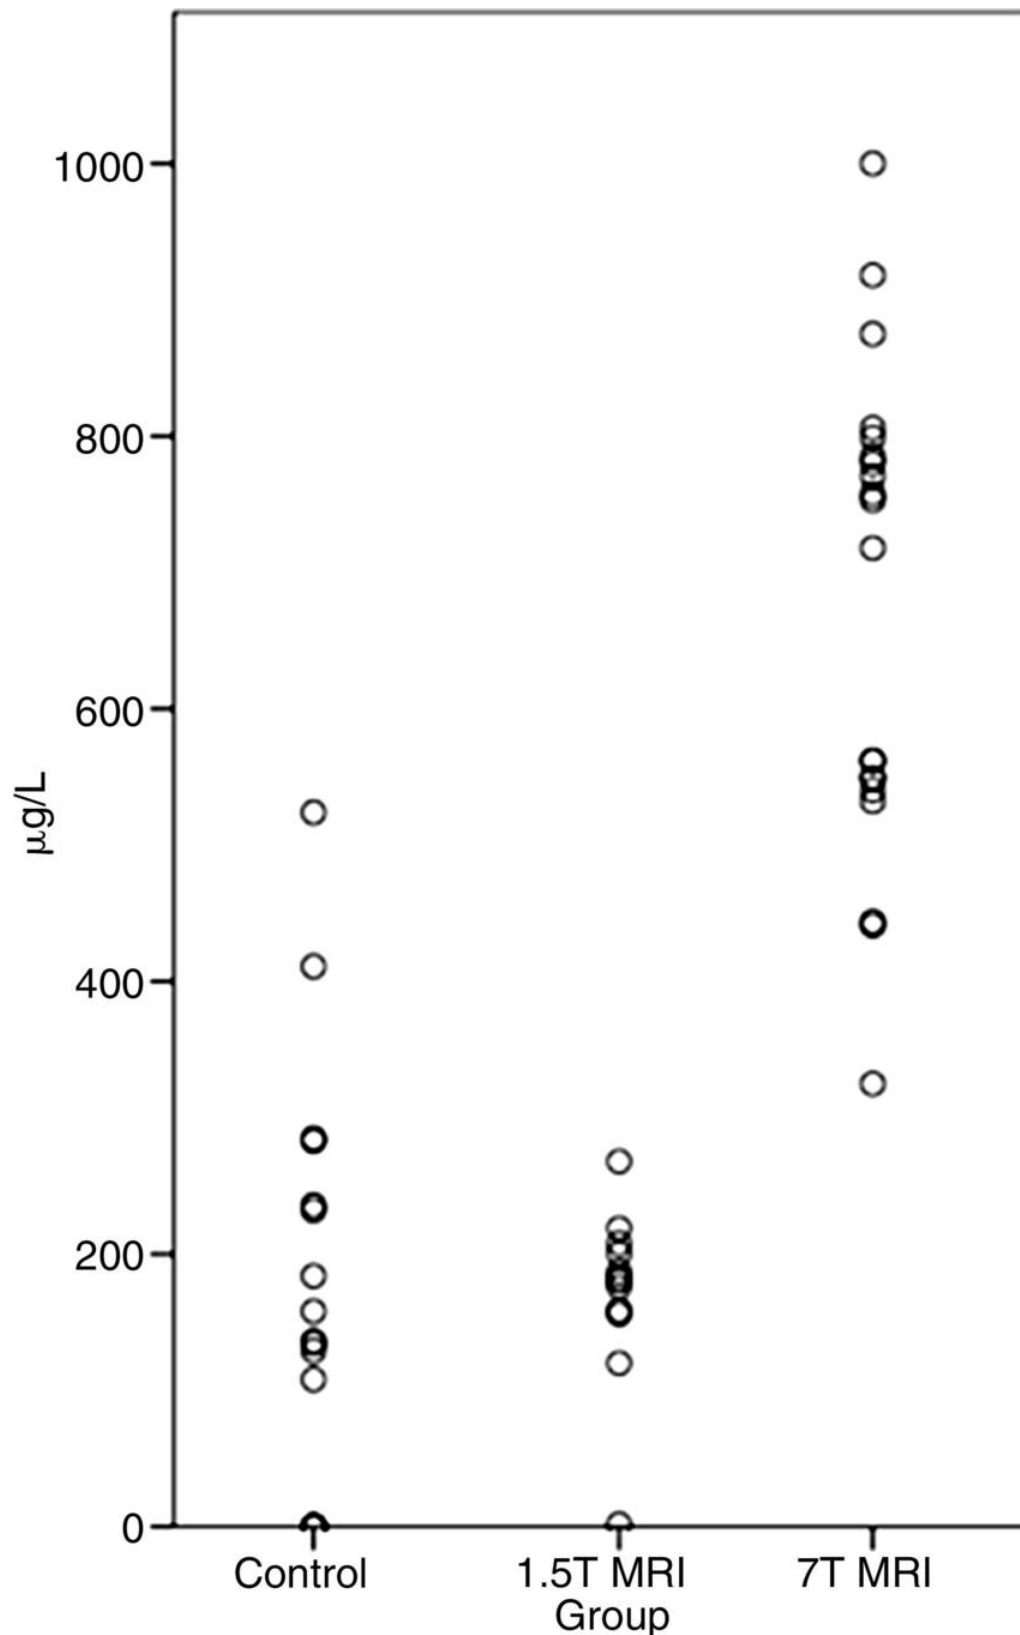
**Figure 3.** Beeswarm plot shows mercury content in artificial saliva of the three groups.

When the researchers analyzed the artificial saliva, the mercury content in the 7-T, 1.5-T and control group was  $0.67 \pm 0.18$ ,  $0.17 \pm 0.06$  and  $0.14 \pm 0.15$  parts per million (ppm), respectively. At 0.67 ppm, the mercury content in the 7-T group was approximately four times the levels found in the 1.5-T group and the control group.
