High-Strength MRI May Release Mercury from Amalgam Dental Fillings

Released: June 26, 2018

"Ex Vivo Mercury Release from Dental Amalgam after 7.0-T and 1.5-T MRI."

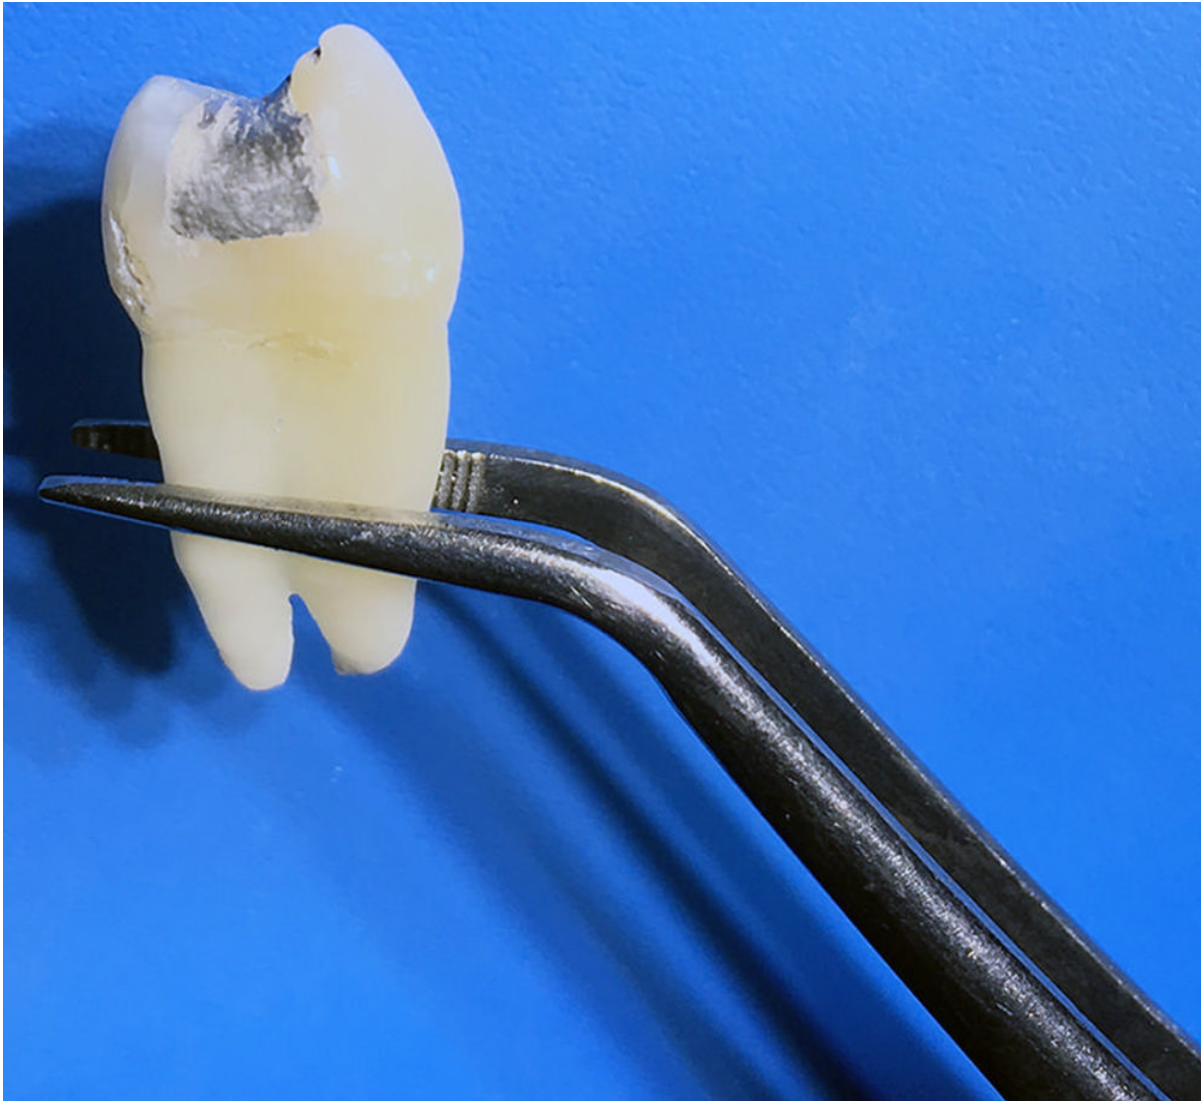
Figure 1. Sample tooth with amalgam filling routinely used in clinical practice.

The researchers opened two-sided cavities in each tooth and applied amalgam fillings. After nine days, two groups of 20 randomly selected teeth were placed in a solution of artificial saliva immediately followed by 20 minutes of exposure to 1.5-T or 7-T MRI. A control group of teeth was placed in artificial saliva only.

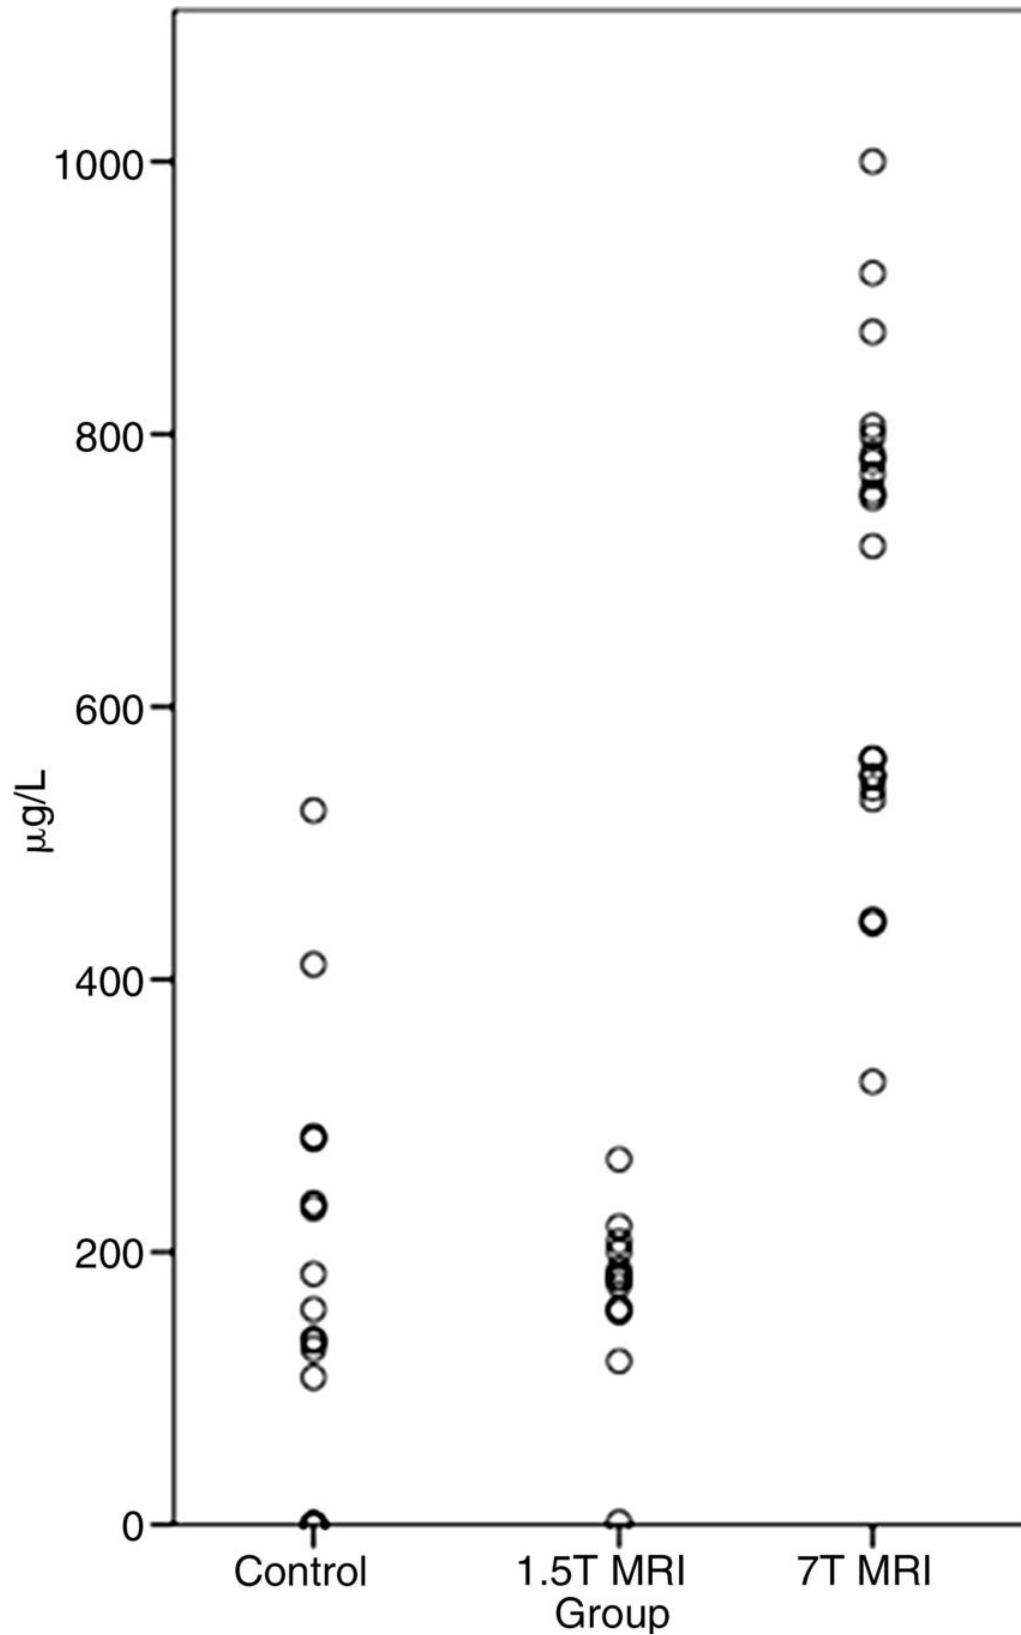
Figure 3. Beeswarm plot shows mercury content in artificial saliva of the three groups.

When the researchers analyzed the artificial saliva, the mercury content in the 7-T, 1.5-T and control group was 0.67 ± 0.18 , 0.17 ± 0.06 and 0.14 ± 0.15 parts per million (ppm), respectively. At 0.67 ppm, the mercury content in the 7-T group was approximately four times the levels found in the 1.5-T group and the control group.
