## Steroid Injections of Hip and Knee May Damage Joints

Released: October 15, 2019

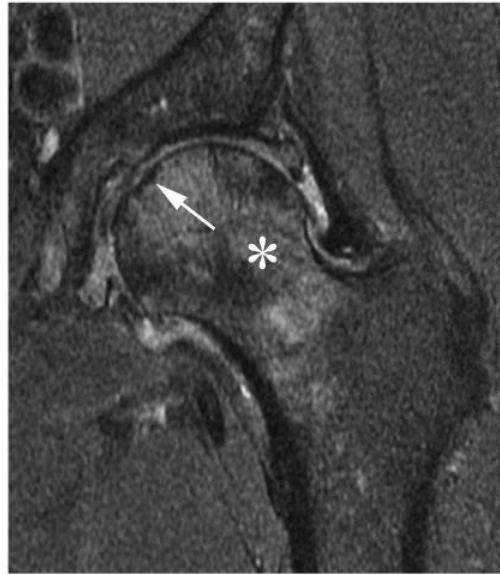
**Figure 2.** Rapid progressive osteoarthritis joint space loss (type 1) and subchondral insufficiency fracture in a 53-year-old man who presented with hip pain. **(a)** Anteroposterior left hip radiograph shows mild osteophytic changes (arrows) and no joint space loss. This patient was referred for intra-articular corticosteroid injection. **(b)** Seven weeks after injection, he returned with worsening hip pain. Repeat anteroposterior left hip radiograph shows accelerated loss of joint space (arrows). **(c)** Sagittal intermediate-weighted fat-suppressed MRI obtained at the same time as **b** shows a linear subchondral hypointensity representing subchondral insufficiency fracture of the anterior superior femoral head with subtle flattening of the overlying articular surface (arrows). Extensive bone marrow edema extends to the femoral neck (\*). **(d)** Corresponding coronal intermediate-weighted fat-suppressed MRI enables us to confirm the presence of a subchondral insufficiency fracture (arrow) and depicts the true extent of bone marrow edema (\*).

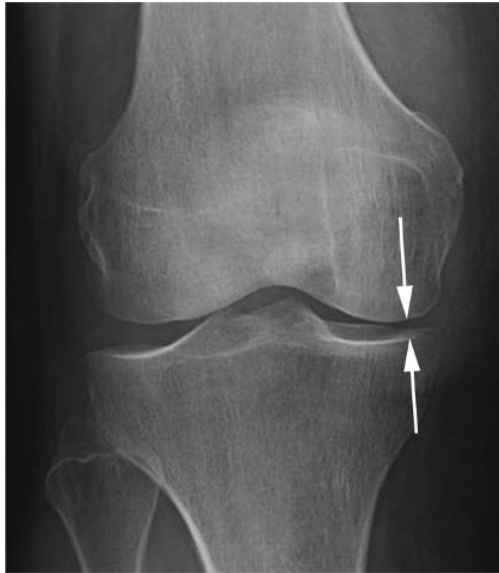
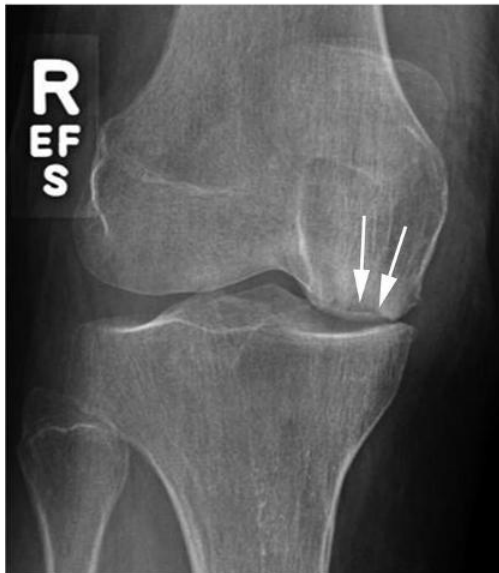
**Figure 3.** Subchondral insufficiency fracture in a 69-year-old woman who presented with acutely worsening knee pain without known trauma. **(a)** Anteroposterior radiograph of the right knee shows possible medial compartment joint space narrowing (arrows) without osteophytes. There are no signs of osteonecrosis or subchondral insufficiency fracture. **(b)** Coronal intermediate-weighted fat-suppressed MRI obtained at the same time as **a** shows a subchondral insufficiency fracture of the medial femoral condyle, without collapse of the articular surface (arrow). In addition, there is marked femoral and tibial bone marrow edema (\*). This patient was not treated with conservative measures (ie, switch to non-weight-bearing activity) and received an intra-articular corticosteroid injection. **(c)** Eleven months later, she returned with continued right knee pain. Repeat anteroposterior radiograph of the right knee shows collapse of the medial femoral condyle articular surface (arrows). **(d)** Coronal intermediate-weighted MRI acquired at the same time as **c** demonstrates deformity of the articular surface (short arrow) of the medial femoral condyle in the area of a previously noted subchondral insufficiency fracture (long arrow). In addition, there is marked bone marrow edema (\*).
