COVID-19 Patients Show Liver Injury Months After Infection

Released: December 1, 2022

CHICAGO — COVID-19 infection is associated with increased liver stiffness, a sign of possible long-term liver injury, according to the results of a new study being presented today at the [annual meeting](#) of the Radiological Society of North America ([RSNA](#)).

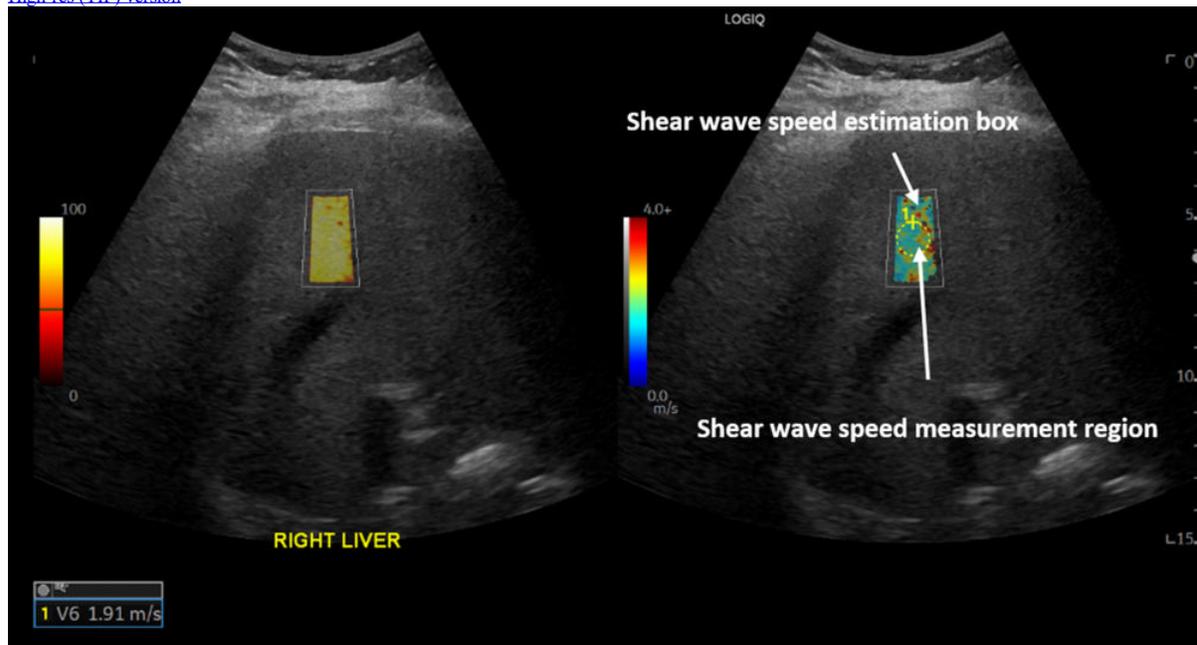
Figure 1. A 55-year-old female with a history of COVID-19 infection 38 weeks before the date of ultrasound shear wave elastography. The shear wave speed of 1.91 m/s corresponds to Young's modulus of 10.94 kPa which indicates abnormally high liver stiffness and may reflect chronic liver injury.

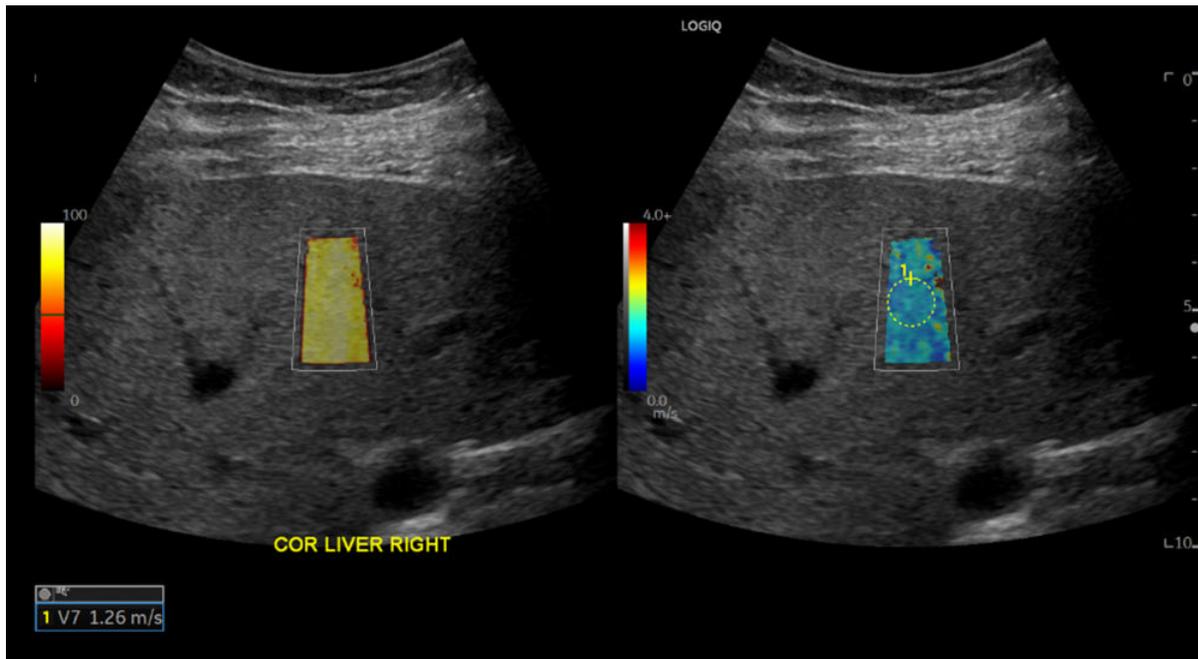
Figure 2. A 57-year-old female without a history of positive COVID-19 test before the date of ultrasound shear wave elastography. The shear wave speed of 1.26 m/s corresponds to Young's modulus of 4.76 kPa which indicates normal liver stiffness.
[High-res \(TIF\) version](#)
