Countertop Workers Exposed to Serious Lung Disease

Released: December 2, 2024

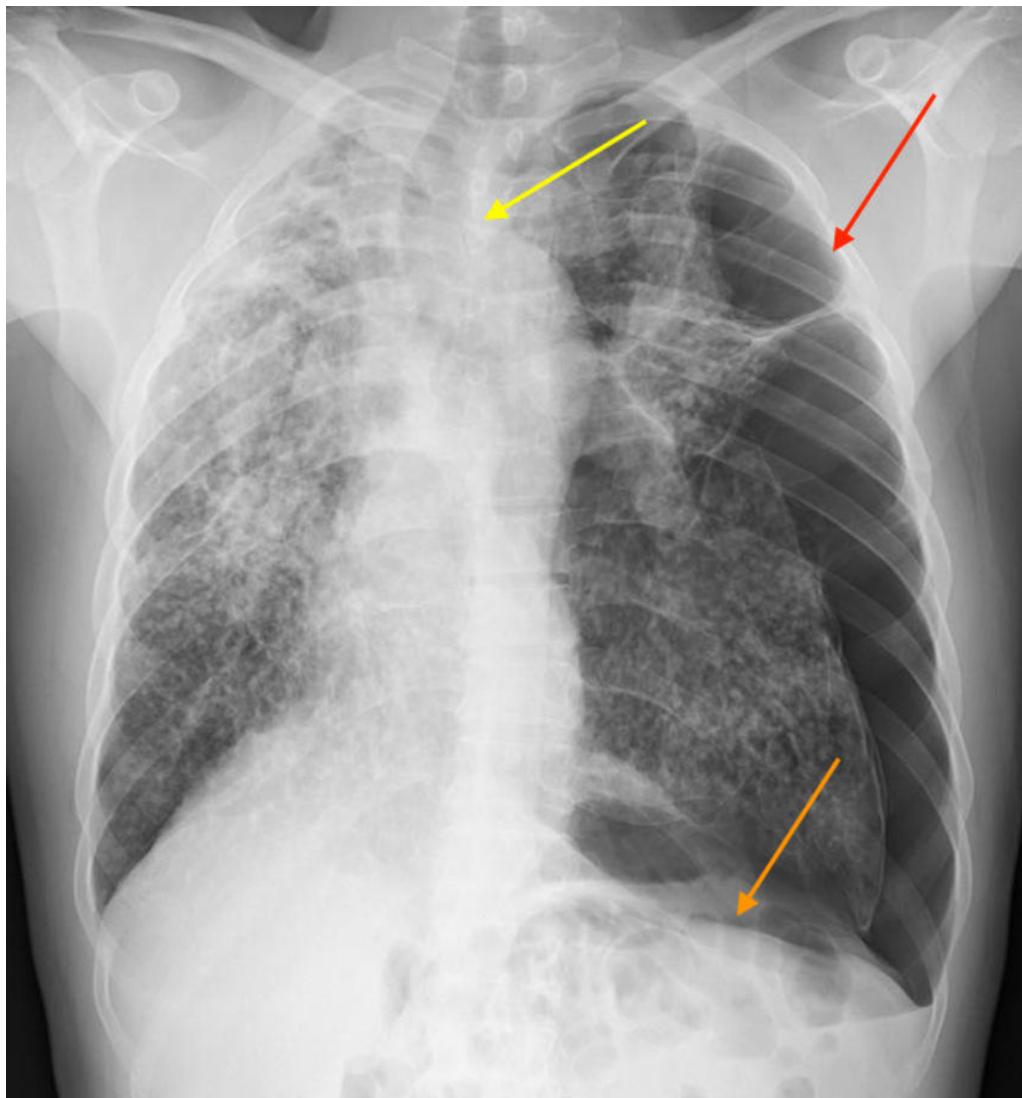
Figure 1. Chest x-ray with a left-sided tension pneumothorax (lung collapse - red arrow), with flattening of the diaphragm (orange arrow) and shift of the mediastinal structures, including the heart and airways (yellow arrow).

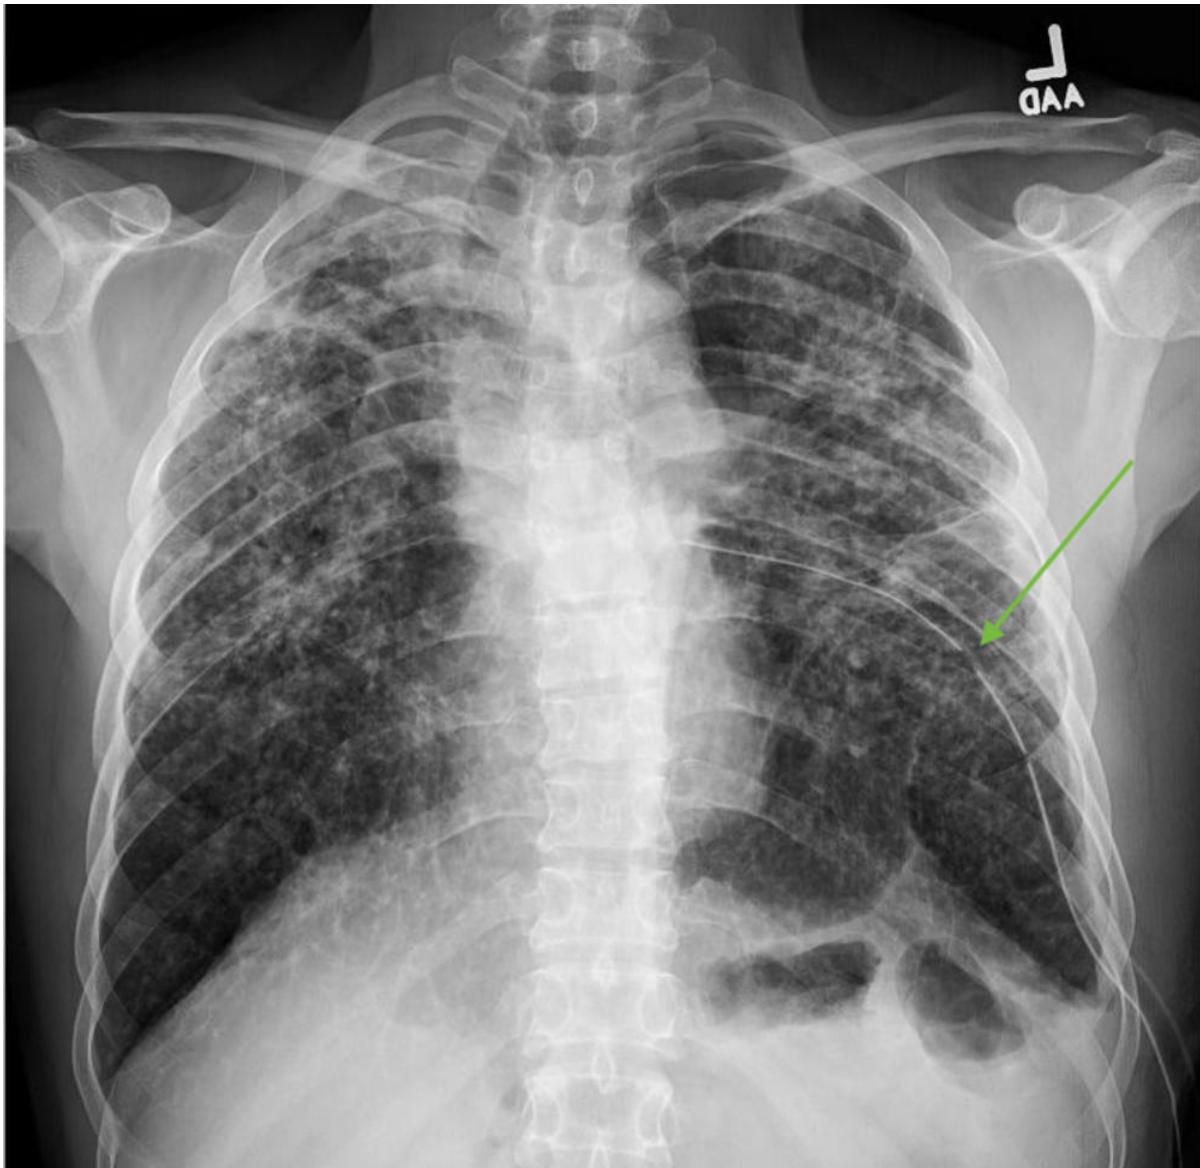
Figure 2. Chest x-ray with placement of a left-sided chest tube (green arrow) and resolution of the tension pneumothorax. There is a background of rounded opacities in the bilateral lung fields, consistent with silicosis.

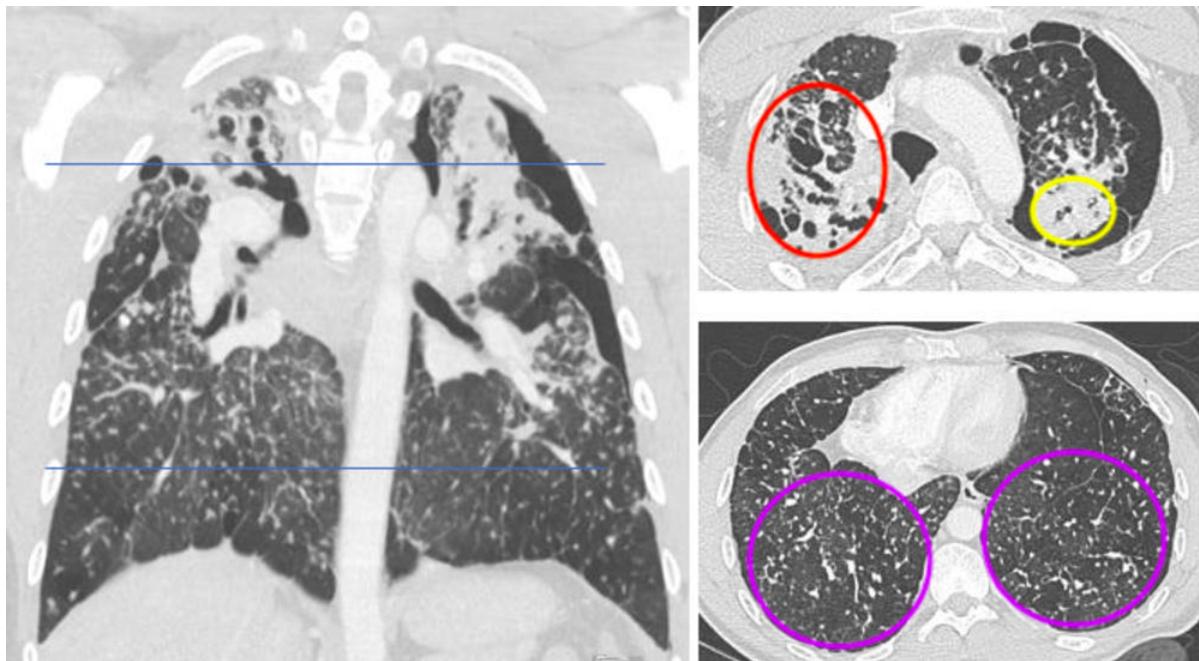
Figure 3. Contrast-enhanced chest computed tomography (CT) with upper predominant fibrosis/lung scarring (red oval), solid masses adjacent to a left-sided pneumothorax (yellow oval) and diffuse silicotic nodules (purple circle). This patient had a history of working in the countertop-cutting industry (15 years), smoking cigarettes (10 pack-years), and active tuberculosis (treated 7 years prior and excluded at the time of this image with laboratory testing).

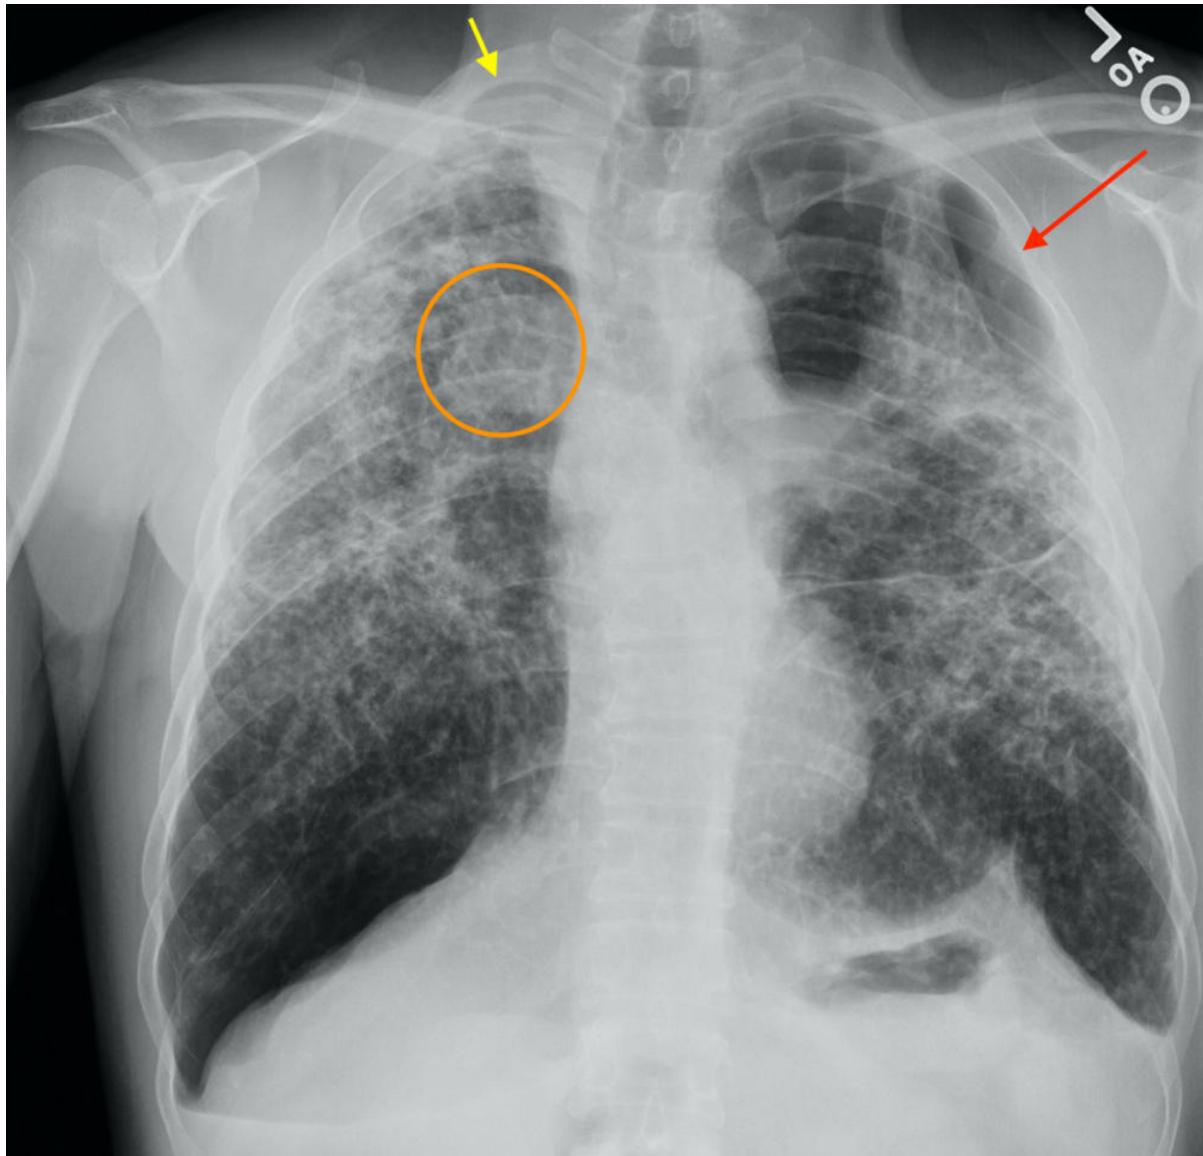
Figure 4. Follow-up chest x-ray. The patient was diagnosed with silicosis based on clinical history, imaging features, and bronchoscopy with biopsy, which demonstrated silica crystals with fibrotic nodules. There is persistent small left-sided pneumothorax/lung collapse (red arrow), asymmetric right upper lung thickening (yellow arrow), and findings consistent with progressive massive fibrosis (orange circle), indicating complicated and advanced silicosis. The patient is still working in the countertop-cutting industry due to lack of other job opportunities.
